Access Compliance Report

Public Rights-of-Way

(Curb Ramps)

| Intersection ID: 5151 | Main Street: HAYBRIDGE_RD | Cross Street: RINDLE_CT | Location: NE |

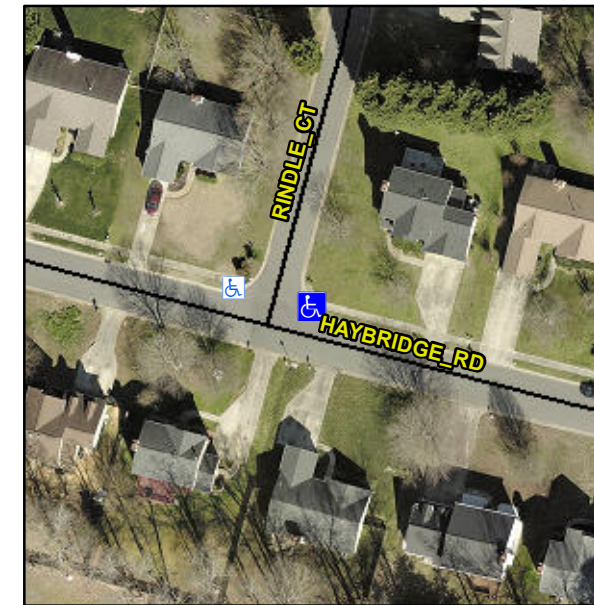
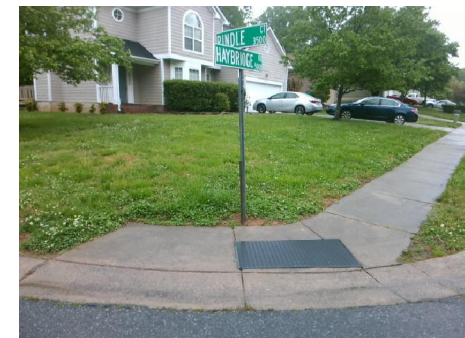
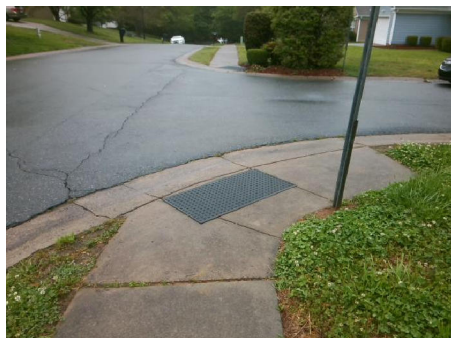
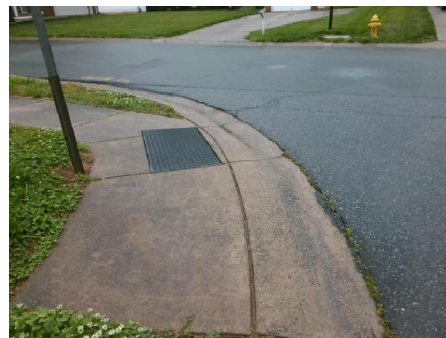
| ADA ID: AF861DA0DE94 | Ramp Type: BlendTrans1 | Initial Pass/Fail: Fail | Overall Compliance: No |

Not Found, R304.5.1, R304.5.3

| Compliance | Description | Data | Compliance | Description | Data |
|---|---|---|---|---|---|
| N/A | Ramp Length (in) | 47.0 | Yes | BlendTrans Slope (%) | 4.5 |
| No | Ramp Width (in) | 36.0 | No | BlendTrans XSlope (%) | 2.1 |
| | | | No | Curb Slope (%) | 10.8 |

Remove & Replace Curb Ramp With Two New Directional Ramps or Equivalent.
