# Access Compliance Report

## Public Rights-of-Way

### (Curb Ramps)

Intersection ID: 18086	Main Street: NATIONS_FORD_RD	Cross Street: RADFORD_AV	Location: NW
ADA ID: AF8897F95943	Ramp Type: Directional1	Initial Pass/Fail: Fail	Overall Compliance: No
Severity Score: 13.75			
Codes/Mitigation Info/Possible Solution		Field Measurements/Component Compliance

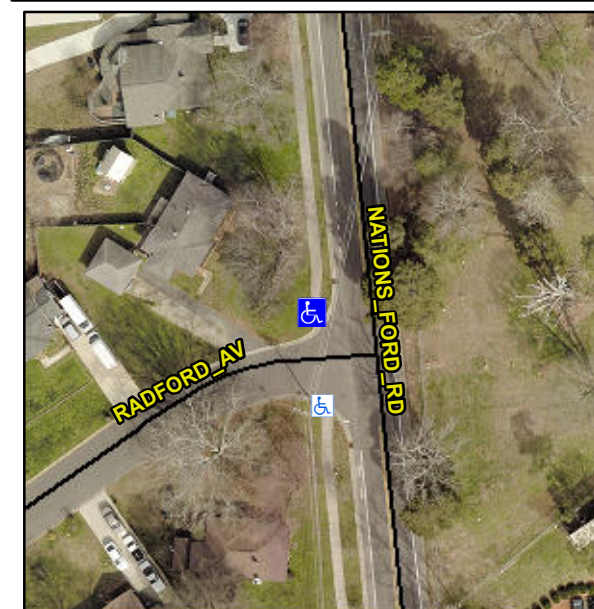
Compliance	Description	Data	Compliance	Description	Data
N/A	Ramp Length (in)	<b>98.0</b>	N/A	Grade Break?	<b>N/A</b>
Yes	Ramp Width (in)	<b>58.0</b>	N/A	Grade Break Slope (%)	<b>0.0</b>
No	Ramp Slope (%)	<b>8.8</b>	N/A	Grade Break XSlope (%)	<b>0.0</b>
No	Ramp XSlope (%)	<b>3.9</b>			
N/A	Flare Type LT	<b>N/A</b>	N/A	Flare Type RT	<b>N/A</b>
N/A	Flare Slope LT (%)	<b>N/A</b>	N/A	Flare Slope RT (%)	<b>0.0</b>
N/A	Flare Traversable LT?	<b>N/A</b>	N/A	Flare Traversable RT?	<b>N/A</b>
N/A	Landing Length (in)	<b>0.0</b>	N/A	DWS Provided?	<b>N/A</b>
N/A	Landing Width (in)	<b>0.0</b>	N/A	DWS Contrast?	<b>N/A</b>
N/A	Landing Slope (%)	<b>0.0</b>	N/A	DWS Length (in)	<b>N/A</b>
N/A	Landing X Slope (%)	<b>0.0</b>	N/A	DWS Full Width?	<b>N/A</b>
N/A	Landing Curb? (Y/N)	<b>N/A</b>	N/A	DWS Offset LT (in)	<b>N/A</b>
N/A	Shared Landing?	<b>N/A</b>	N/A	DWS Offset RT (in)	<b>N/A</b>
N/A	Gutter Ponding?	<b>0.0</b>	N/A	Gutter Slope (%)	<b>N/A</b>

N/A	Gutter Lip Ht (in)	<b>0.0</b>	N/A	Gutter X Slope (%)	<b>N/A</b>
N/A	Painted X Walk1?	<b>No</b>		Road Slope (%)	<b>0.1</b>
	X Walk 1 Direction	<b>To SE</b>		Road X Slope (%)	<b>3.8</b>
	X Walk 1 Width (in)	<b>N/A</b>		Clear Space?	<b>N/A</b>
	X Walk 1 Slope (%)	<b>0.1</b>	N/A	Clear Space to XWalk (in)	<b>N/A</b>
	X Walk 1 X Slope (%)	<b>3.8</b>	N/A	Storm Grate/Utility Hazard?	<b>N/A</b>
N/A	Ramp inside XWalk1?	<b>N/A</b>		Storm Grate/Utility Type	
N/A	Any Obstructions?	<b>N/A</b>			<b>N/A</b>
	Obstruction Type		Yes	Surface Condition? (G/P)	<b>Good</b>
			N/A	Curb Slope (%)	<b>10.0</b>

**Remove & Replace Entire Ramp.**
