Access Compliance Report

Public Rights-of-Way

(Curb Ramps)

Intersection ID: 10003849	Main Street: DIXIE_RIVER_RD	Cross Street: NEW_FASHION_WY	Location: SW
ADA ID: AF8BF648903F	Ramp Type: Perp	Initial Pass/Fail: Fail	Overall Compliance: No
		Severity Score: 8.75

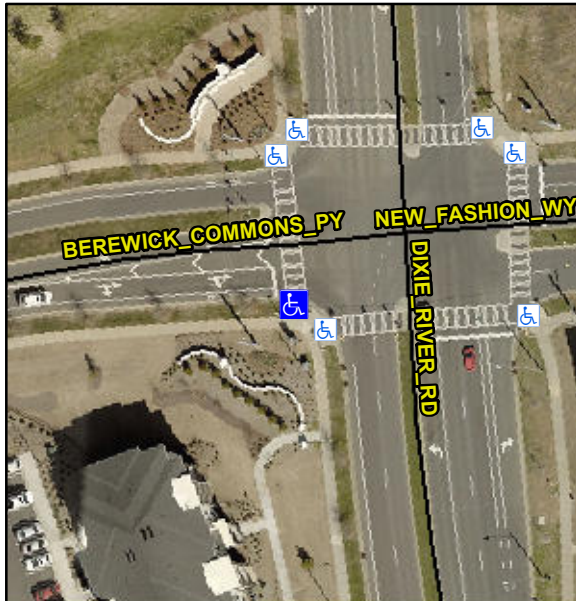
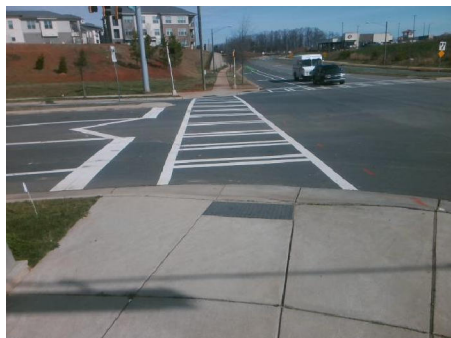
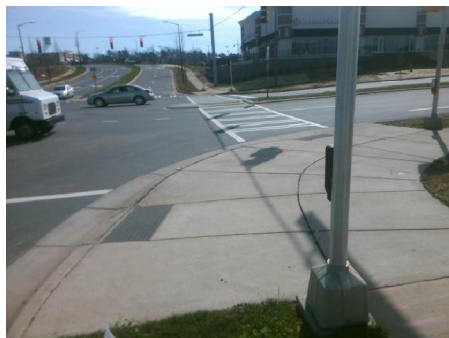
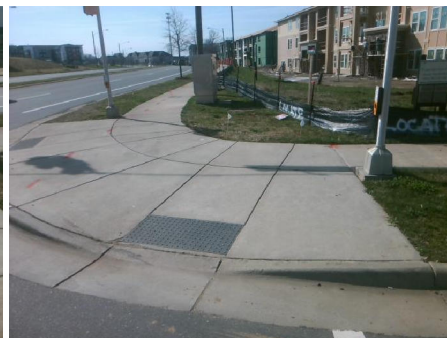
Not Found, R304.5.1

Compliance	Description	Data	Compliance	Description	Data
N/A	Ramp Length (in)	100.0	Yes	Ramp Slope (%)	6.0
No	Ramp Width (in)	47.0	Yes	Ramp XSlope (%)	0.2
N/A	Flare Type LT	N/A	N/A	Flare Type RT	N/A
N/A	Flare Slope LT (%)	N/A	N/A	Flare Slope RT (%)	N/A
N/A	Flare Traversable LT?	N/A	N/A	Flare Traversable RT?	N/A
N/A	Landing Length (in)	N/A	N/A	DWS Provided?	N/A
N/A	Landing Width (in)	N/A	N/A	DWS Contrast?	N/A
N/A	Landing Slope (%)	N/A	N/A	DWS Length (in)	N/A
N/A	Landing X Slope (%)	N/A	N/A	DWS Full Width?	N/A
N/A	Landing Curb? (Y/N)	N/A	N/A	DWS Offset (in)	N/A
N/A	Shared Landing?	N/A			
N/A	Gutter Ponding?	N/A	N/A	Gutter Slope (%)	N/A
N/A	Gutter Lip Ht (in)	N/A	N/A	Gutter X Slope (%)	N/A
N/A	Painted X Walk1?	Yes	N/A	Painted X Walk2?	N/A
	X Walk 1 Direction	To N		X Walk 2 Direction	N/A
N/A	X Walk 1 Width (in)	114.0	N/A	X Walk 2 Width (in)	N/A
	X Walk 1 Slope (%)	1.3		X Walk 2 Slope (%)	N/A
	X Walk 1 X Slope (%)	0.8		X Walk 2 X Slope (%)	N/A

N/A	Ramp inside XWalk1?	Yes	N/A	Ramp inside XWalk2?	N/A
	Road Slope (%)	N/A	N/A	Clear Space?	N/A
	Road X Slope (%)	N/A	N/A	Clear Space to XWalk (in)	N/A
N/A	Any Obstructions?	N/A	N/A	Storm Grate/Utility Hazard?	N/A
	Obstruction Type			Storm Grate/Utility Type	
		N/A			N/A
			Yes	Surface Condition? (G/P)	Good

Possible Solutions:

Remove & Replace Entire Ramp.
