Access Compliance Report

Public Rights-of-Way

(Curb Ramps)

Intersection ID: 22882	Main Street: SARDIS_POINTE_RD	Cross Street: SARDIS_RD	Location: W
ADA ID: AF8C923AAC0F	Ramp Type: Perp	Initial Pass/Fail: Fail	Overall Compliance: No
		Severity Score: 25

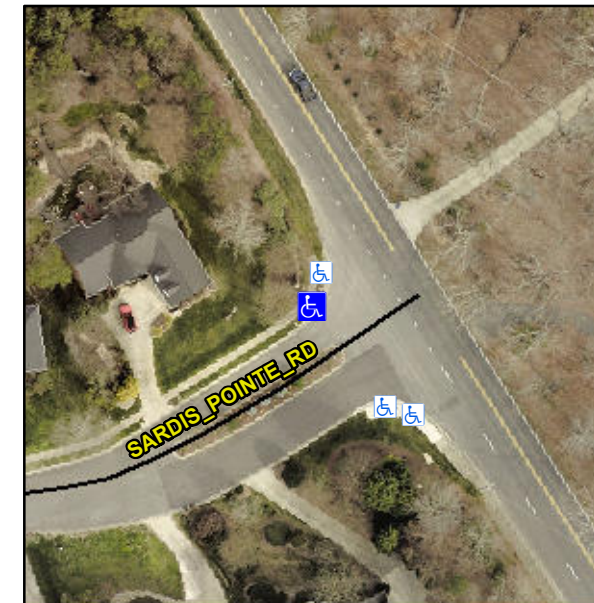
Not Found, R304.5.3

Compliance	Description	Data	Compliance	Description	Data
N/A	Ramp Length (in)	50.0	Yes	Ramp Slope (%)	5.4
Yes	Ramp Width (in)	48.0	No	Ramp XSlope (%)	9.0
N/A	Flare Type LT	N/A	N/A	Flare Type RT	N/A
N/A	Flare Slope LT (%)	N/A	N/A	Flare Slope RT (%)	N/A
N/A	Flare Traversable LT?	N/A	N/A	Flare Traversable RT?	N/A
N/A	Landing Length (in)	N/A	N/A	DWS Provided?	N/A
N/A	Landing Width (in)	N/A	N/A	DWS Contrast?	N/A
N/A	Landing Slope (%)	N/A	N/A	DWS Length (in)	N/A
N/A	Landing X Slope (%)	N/A	N/A	DWS Full Width?	N/A
N/A	Landing Curb? (Y/N)	N/A	N/A	DWS Offset (in)	N/A
N/A	Shared Landing?	N/A			
N/A	Gutter Ponding?	N/A	N/A	Gutter Slope (%)	N/A
N/A	Gutter Lip Ht (in)	N/A	N/A	Gutter X Slope (%)	N/A
N/A	Painted X Walk1?	No	N/A	Painted X Walk2?	N/A
	X Walk 1 Direction	To SE		X Walk 2 Direction	N/A
N/A	X Walk 1 Width (in)	N/A	N/A	X Walk 2 Width (in)	N/A
	X Walk 1 Slope (%)	0.2		X Walk 2 Slope (%)	N/A
	X Walk 1 X Slope (%)	7.3		X Walk 2 X Slope (%)	N/A

N/A	Ramp inside XWalk1?	N/A	N/A	Ramp inside XWalk2?	N/A
	Road Slope (%)	N/A	N/A	Clear Space?	N/A
	Road X Slope (%)	N/A	N/A	Clear Space to XWalk (in)	N/A
N/A	Any Obstructions?	N/A	N/A	Storm Grate/Utility Hazard?	N/A
	Obstruction Type			Storm Grate/Utility Type	
		N/A			N/A
			Yes	Surface Condition? (G/P)	Good

Possible Solutions:

Remove & Replace Entire Ramp.
