Access Compliance Report

Public Rights-of-Way

(Curb Ramps)

Intersection ID: 54374	Main Street: GRIER_RD	Cross Street: OLD_CONCORD_RD	Location: SW
ADA ID: AF904204E6BD	Ramp Type: Perp	Initial Pass/Fail: Fail	Overall Compliance: No
Codes/Mitigation Info/Possible Solution			Severity Score: 10
			Field Measurements/Component Compliance

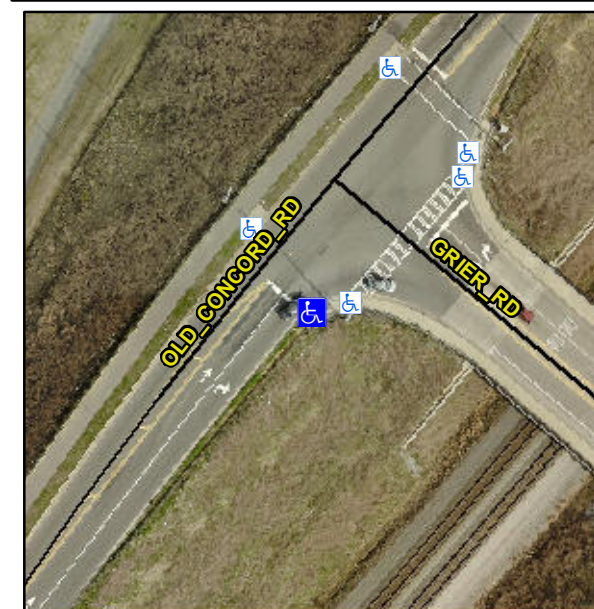
R304.5.1, R304.5.3

Compliance	Description	Data	Compliance	Description	Data
N/A	Ramp Length (in)	82.0	Yes	Ramp Slope (%)	6.7
No	Ramp Width (in)	47.5	No	Ramp XSlope (%)	4.2
N/A	Flare Type LT	N/A	N/A	Flare Type RT	N/A
N/A	Flare Slope LT (%)	N/A	N/A	Flare Slope RT (%)	N/A
N/A	Flare Traversable LT?	N/A	N/A	Flare Traversable RT?	N/A
N/A	Landing Length (in)	N/A	N/A	DWS Provided?	N/A
N/A	Landing Width (in)	N/A	N/A	DWS Contrast?	N/A
N/A	Landing Slope (%)	N/A	N/A	DWS Length (in)	N/A
N/A	Landing X Slope (%)	N/A	N/A	DWS Full Width?	N/A
N/A	Landing Curb? (Y/N)	N/A	N/A	DWS Offset (in)	N/A
N/A	Shared Landing?	N/A			
N/A	Gutter Ponding?	N/A	N/A	Gutter Slope (%)	N/A
N/A	Gutter Lip Ht (in)	N/A	N/A	Gutter X Slope (%)	N/A
N/A	Painted X Walk1?	No	N/A	Painted X Walk2?	N/A
	X Walk 1 Direction	To NW		X Walk 2 Direction	N/A
N/A	X Walk 1 Width (in)	N/A	N/A	X Walk 2 Width (in)	N/A
	X Walk 1 Slope (%)	1.0		X Walk 2 Slope (%)	N/A
	X Walk 1 X Slope (%)	2.3		X Walk 2 X Slope (%)	N/A

N/A	Ramp inside XWalk1?	N/A	N/A	Ramp inside XWalk2?	N/A
	Road Slope (%)	N/A	N/A	Clear Space?	N/A
	Road X Slope (%)	N/A	N/A	Clear Space to XWalk (in)	N/A
N/A	Any Obstructions?	N/A	N/A	Storm Grate/Utility Hazard?	N/A
	Obstruction Type			Storm Grate/Utility Type	
		N/A			N/A
			Yes	Surface Condition? (G/P)	Good

Remove & Replace Entire Ramp.
