Access Compliance Report

Public Rights-of-Way

(Curb Ramps)

Intersection ID: 14014	Main Street: N_SHARON_AMITY_RD	Cross Street: WILORA_LAKE_RD	Location: NW
ADA ID: AFAD2831EA65	Ramp Type: Perp	Initial Pass/Fail: Fail	Overall Compliance: No
		Severity Score: 30

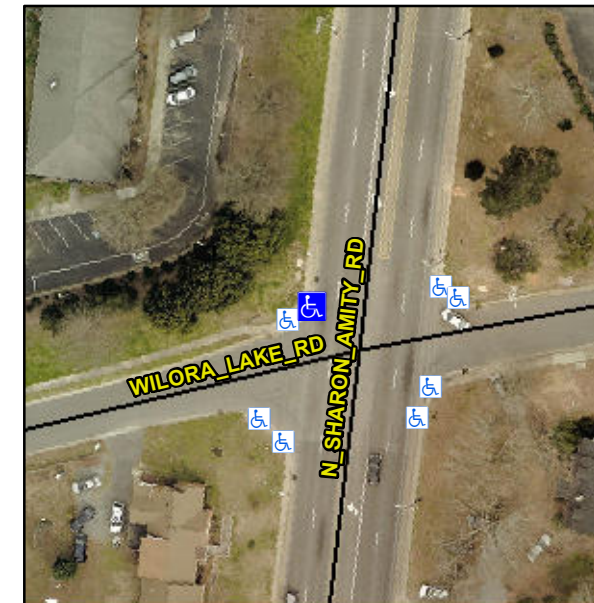
Not Found, R304.5.1, R304.2.2

Compliance	Description	Data	Compliance	Description	Data
N/A	Ramp Length (in)	58.0	No	Ramp Slope (%)	9.8
No	Ramp Width (in)	34.0	Yes	Ramp XSlope (%)	0.9
N/A	Flare Type LT	N/A	N/A	Flare Type RT	N/A
N/A	Flare Slope LT (%)	N/A	N/A	Flare Slope RT (%)	N/A
N/A	Flare Traversable LT?	N/A	N/A	Flare Traversable RT?	N/A
N/A	Landing Length (in)	N/A	N/A	DWS Provided?	N/A
N/A	Landing Width (in)	N/A	N/A	DWS Contrast?	N/A
N/A	Landing Slope (%)	N/A	N/A	DWS Length (in)	N/A
N/A	Landing X Slope (%)	N/A	N/A	DWS Full Width?	N/A
N/A	Landing Curb? (Y/N)	N/A	N/A	DWS Offset (in)	N/A
N/A	Shared Landing?	N/A			
N/A	Gutter Ponding?	N/A	N/A	Gutter Slope (%)	N/A
N/A	Gutter Lip Ht (in)	N/A	N/A	Gutter X Slope (%)	N/A
N/A	Painted X Walk1?	No	N/A	Painted X Walk2?	N/A
	X Walk 1 Direction	To E		X Walk 2 Direction	N/A
N/A	X Walk 1 Width (in)	N/A	N/A	X Walk 2 Width (in)	N/A
	X Walk 1 Slope (%)	4.6		X Walk 2 Slope (%)	N/A
	X Walk 1 X Slope (%)	2.2		X Walk 2 X Slope (%)	N/A

N/A	Ramp inside XWalk1?	N/A	N/A	Ramp inside XWalk2?	N/A
	Road Slope (%)	N/A	N/A	Clear Space?	N/A
	Road X Slope (%)	N/A	N/A	Clear Space to XWalk (in)	N/A
N/A	Any Obstructions?	N/A	N/A	Storm Grate/Utility Hazard?	N/A
	Obstruction Type			Storm Grate/Utility Type	
		N/A			N/A
			Yes	Surface Condition? (G/P)	Good

Remove & Replace Entire Ramp.

Total Cost: \$ 1850.00
