Access Compliance Report

Public Rights-of-Way

(Curb Ramps)

Intersection ID: 11707	Main Street: N_GRAHAM_ST	Cross Street: W_6TH_ST	Location: NE
ADA ID: AFB31AE49931	Ramp Type: Perp	Initial Pass/Fail: Pass	Overall Compliance: No
Severity Score: 0.25			
Codes/Mitigation Info/Possible Solution		Field Measurements/Component Compliance

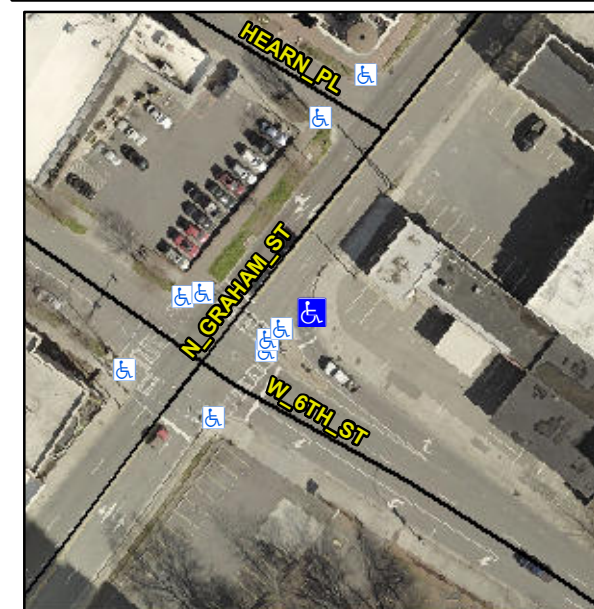
Not Found, R304.2.2-Perp, R304.3.2-Para

Compliance	Description	Data	Compliance	Description	Data
N/A	Ramp Length (in)	59.0	Yes	Ramp Slope (%)	8.0
Yes	Ramp Width (in)	48.0	Yes	Ramp XSlope (%)	3.1
N/A	Flare Type LT	Sloped	N/A	Flare Type RT	N/A
N/A	Flare Slope LT (%)	5.9	Yes	Flare Slope RT (%)	6.1
N/A	Flare Traversable LT?	Yes	N/A	Flare Traversable RT?	Yes
Yes	Landing Length (in)	81.0	Yes	DWS Provided?	Yes
Yes	Landing Width (in)	48.0	Yes	DWS Contrast?	Yes
No	Landing Slope (%)	2.7	Yes	DWS Length (in)	24.0
Yes	Landing X Slope (%)	2.4	Yes	DWS Full Width?	Yes
N/A	Landing Curb? (Y/N)	No	Yes	DWS Offset (in)	0.0
N/A	Shared Landing?	No			
Yes	Gutter Ponding?	No	Yes	Gutter Slope (%)	2.4
Yes	Gutter Lip Ht (in)	0.0	Yes	Gutter X Slope (%)	2.9
N/A	Painted X Walk1?	Yes	N/A	Painted X Walk2?	N/A
	X Walk 1 Direction	To W		X Walk 2 Direction	N/A
N/A	X Walk 1 Width (in)	148.0	N/A	X Walk 2 Width (in)	N/A
	X Walk 1 Slope (%)	9.4		X Walk 2 Slope (%)	N/A
	X Walk 1 X Slope (%)	4.4		X Walk 2 X Slope (%)	N/A

Yes	Ramp inside XWalk1?	Yes	N/A	Ramp inside XWalk2?	N/A
	Road Slope (%)	N/A	N/A	Clear Space?	Yes
	Road X Slope (%)	N/A	N/A	Clear Space to XWalk (in)	N/A
Yes	Any Obstructions?	No	Yes	Storm Grate/Utility Hazard?	No
	Obstruction Type			Storm Grate/Utility Type	
		N/A			N/A
			Yes	Surface Condition? (G/P)	Good

Possible Solutions:

Remove & Replace Entire Ramp.

Total Cost: \$ 1850.00
