Access Compliance Report

Public Rights-of-Way

(Curb Ramps)

Intersection ID: 18813	Main Street: BUCKINGHAM_DR	Cross Street: SENECA_PL	Location: SW
ADA ID: AFB62F6830A0	Ramp Type: Perp	Initial Pass/Fail: Fail	Overall Compliance: No
Severity Score: 10			
Codes/Mitigation Info/Possible Solution		Field Measurements/Component Compliance

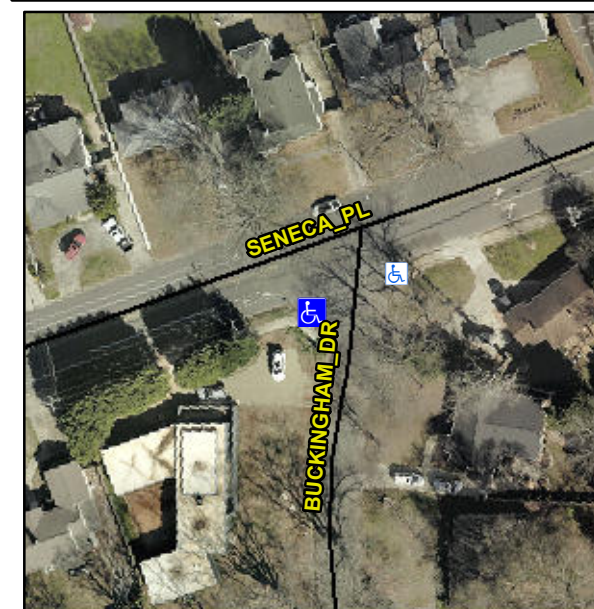
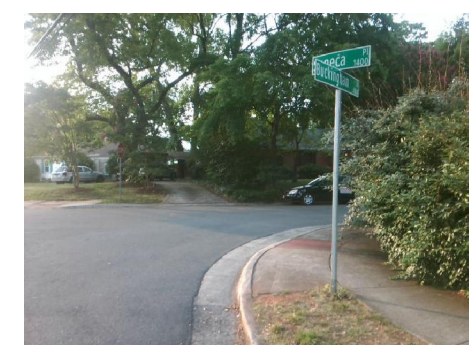
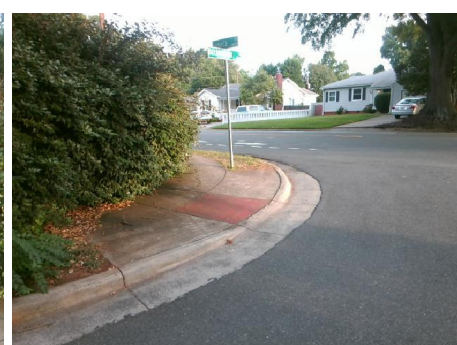
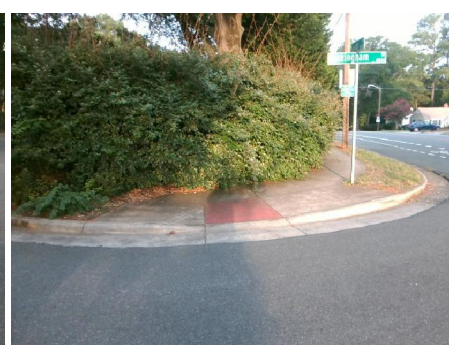
Compliance	Description	Data	Compliance	Description	Data
N/A	Ramp Length (in)	49.0	Yes	Ramp Slope (%)	5.7
No	Ramp Width (in)	42.0	No	Ramp XSlope (%)	3.2
N/A	Flare Type LT	N/A	N/A	Flare Type RT	N/A
N/A	Flare Slope LT (%)	N/A	N/A	Flare Slope RT (%)	N/A
N/A	Flare Traversable LT?	N/A	N/A	Flare Traversable RT?	N/A
N/A	Landing Length (in)	N/A	N/A	DWS Provided?	N/A
N/A	Landing Width (in)	N/A	N/A	DWS Contrast?	N/A
N/A	Landing Slope (%)	N/A	N/A	DWS Length (in)	N/A
N/A	Landing X Slope (%)	N/A	N/A	DWS Full Width?	N/A
N/A	Landing Curb? (Y/N)	N/A	N/A	DWS Offset (in)	N/A
N/A	Shared Landing?	N/A			
N/A	Gutter Ponding?	N/A	N/A	Gutter Slope (%)	N/A
N/A	Gutter Lip Ht (in)	N/A	N/A	Gutter X Slope (%)	N/A
N/A	Painted X Walk1?	No	N/A	Painted X Walk2?	N/A
	X Walk 1 Direction	To E		X Walk 2 Direction	N/A
N/A	X Walk 1 Width (in)	N/A	N/A	X Walk 2 Width (in)	N/A
	X Walk 1 Slope (%)	1.7		X Walk 2 Slope (%)	N/A
	X Walk 1 X Slope (%)	1.3		X Walk 2 X Slope (%)	N/A

N/A	Ramp inside XWalk1?	N/A	N/A	Ramp inside XWalk2?	N/A
	Road Slope (%)	N/A	N/A	Clear Space?	N/A
	Road X Slope (%)	N/A	N/A	Clear Space to XWalk (in)	N/A
N/A	Any Obstructions?	N/A	N/A	Storm Grate/Utility Hazard?	N/A
	Obstruction Type			Storm Grate/Utility Type	
		N/A			N/A
			Yes	Surface Condition? (G/P)	Good

Possible Solutions:

Remove & Replace Entire Ramp.

R304.5.1, R304.5.3
