Access Compliance Report

Public Rights-of-Way

(Curb Ramps)

Intersection ID: 11195	Main Street: DELGANY_DR	Cross Street: GLENVILLE_AV	Location: NE
ADA ID: AFB73CECB514	Ramp Type: BlendTrans1	Initial Pass/Fail: Fail	Overall Compliance: No
		Severity Score: 10

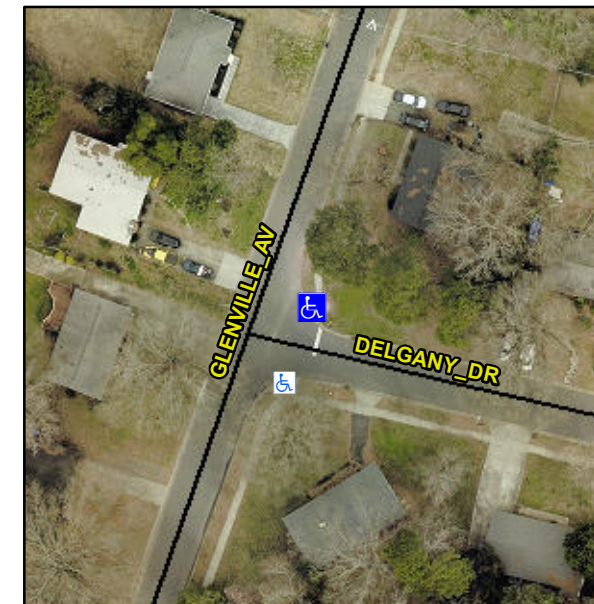
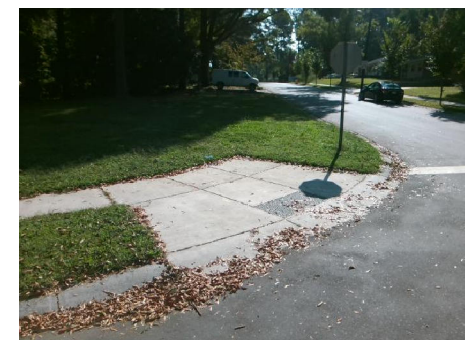
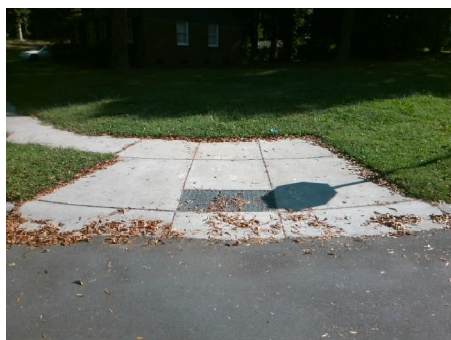
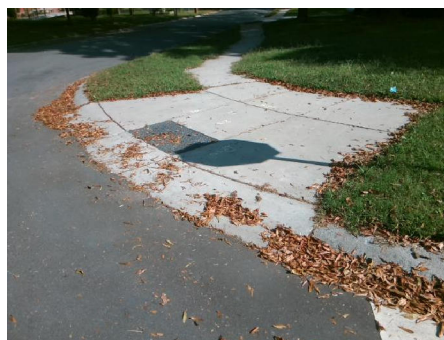
Not Found, R304.5.1, R304.5.3

Compliance	Description	Data	Compliance	Description	Data
N/A	Ramp Length (in)	75.0	Yes	BlendTrans Slope (%)	2.7
No	Ramp Width (in)	46.5	No	BlendTrans XSlope (%)	2.3
N/A	Flare Type LT	N/A	N/A	Flare Type RT	N/A
N/A	Flare Slope LT (%)	N/A	N/A	Flare Slope RT (%)	N/A
N/A	Flare Traversable LT?	N/A	N/A	Flare Traversable RT?	N/A
N/A	Landing Length (in)	N/A	N/A	DWS Provided?	N/A
N/A	Landing Width (in)	N/A	N/A	DWS Contrast?	N/A
N/A	Landing Slope (%)	N/A	N/A	DWS Length (in)	N/A
N/A	Landing X Slope (%)	N/A	N/A	DWS Full Width?	N/A
N/A	Landing Curb? (Y/N)	N/A	N/A	DWS Offset (in)	N/A
N/A	Shared Landing?	N/A			
N/A	Gutter Ponding?	N/A	N/A	Gutter Slope (%)	N/A
N/A	Gutter Lip Ht (in)	N/A	N/A	Gutter X Slope (%)	N/A
N/A	Painted X Walk1?	No	N/A	Painted X Walk2?	N/A
	X Walk 1 Direction	To S		X Walk 2 Direction	N/A
	X Walk 1 Width (in)	N/A		X Walk 2 Width (in)	N/A
	X Walk 1 Slope (%)	1.0		X Walk 2 Slope (%)	N/A
	X Walk 1 X Slope (%)	3.0		X Walk 2 X Slope (%)	N/A

N/A	Ramp inside XWalk1?	N/A	N/A	Ramp inside XWalk2?	N/A
	Road Slope (%)	3.0		Clear Space?	N/A
	Road X Slope (%)	1.0	N/A	Clear Space to XWalk (in)	N/A
N/A	Any Obstructions?	N/A	N/A	Storm Grate/Utility Hazard?	N/A
	Obstruction Type			Storm Grate/Utility Type	
		N/A			N/A
			Yes	Surface Condition? (G/P)	Good
			No	Curb Slope (%)	12.7

Remove & Replace Curb Ramp With Two New Directional Ramps or Equivalent.
