Access Compliance Report

Public Rights-of-Way

(Curb Ramps)

Intersection ID: 14401	Main Street: BAXTER_ST	Cross Street: BALDWIN_AV	Location: SW
ADA ID: AFCA6B5E12A9	Ramp Type: PerpDiag	Initial Pass/Fail: Fail	Overall Compliance: No
Severity Score: 13.75			
Codes/Mitigation Info/Possible Solution		Field Measurements/Component Compliance

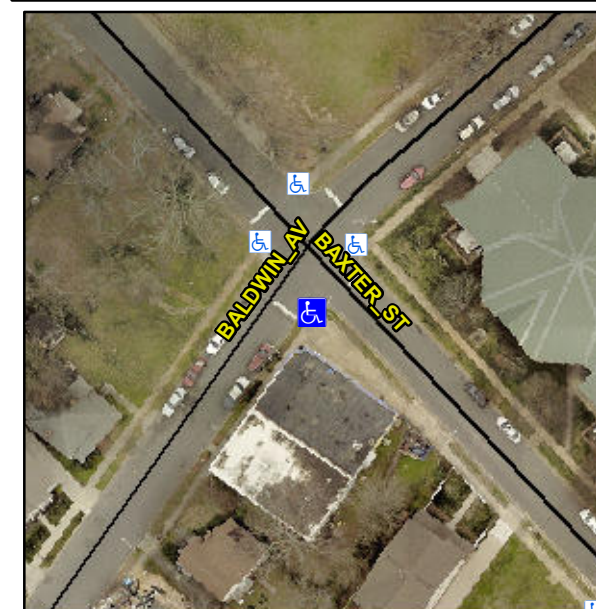
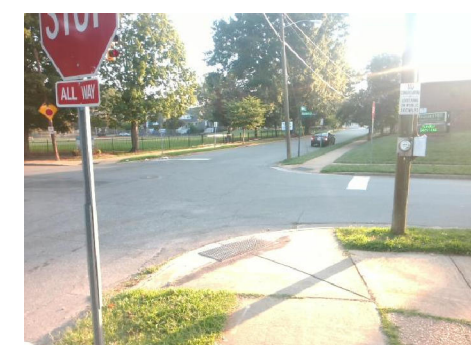
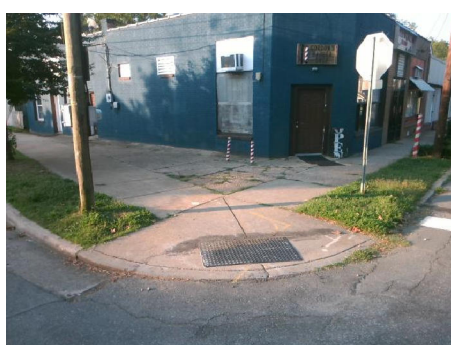
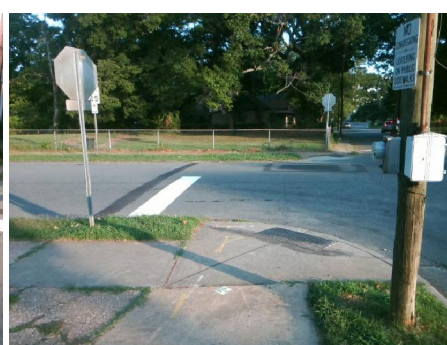
Not Found, R304.2.2, R304.5.3

Compliance	Description	Data	Compliance	Description	Data
N/A	Ramp Length (in)	64.0	No	Ramp Slope (%)	8.8
Yes	Ramp Width (in)	48.0	No	Ramp XSlope (%)	3.3
N/A	Flare Type LT	N/A	N/A	Flare Type RT	N/A
N/A	Flare Slope LT (%)	N/A	N/A	Flare Slope RT (%)	N/A
N/A	Flare Traversable LT?	N/A	N/A	Flare Traversable RT?	N/A
N/A	Landing Length (in)	N/A	N/A	DWS Provided?	N/A
N/A	Landing Width (in)	N/A	N/A	DWS Contrast?	N/A
N/A	Landing Slope (%)	N/A	N/A	DWS Length (in)	N/A
N/A	Landing X Slope (%)	N/A	N/A	DWS Full Width?	N/A
N/A	Landing Curb? (Y/N)	N/A	N/A	DWS Offset (in)	N/A
N/A	Shared Landing?	N/A			
N/A	Gutter Ponding?	N/A	N/A	Gutter Slope (%)	N/A
N/A	Gutter Lip Ht (in)	N/A	N/A	Gutter X Slope (%)	N/A
N/A	Painted X Walk1?	No	N/A	Painted X Walk2?	No
	X Walk 1 Direction	To NE		X Walk 2 Direction	To NW
N/A	X Walk 1 Width (in)	N/A	N/A	X Walk 2 Width (in)	N/A
	X Walk 1 Slope (%)	3.3		X Walk 2 Slope (%)	3.3
	X Walk 1 X Slope (%)	0.3		X Walk 2 X Slope (%)	2.0

N/A	Ramp inside XWalk1?	N/A	N/A	Ramp inside XWalk2?	N/A
	Road Slope (%)	2.2	N/A	Clear Space?	N/A
	Road X Slope (%)	0.6	N/A	Clear Space to XWalk (in)	N/A
N/A	Any Obstructions?	N/A	N/A	Storm Grate/Utility Hazard?	N/A
	Obstruction Type			Storm Grate/Utility Type	
		N/A			N/A
			Yes	Surface Condition? (G/P)	Good

Remove & Replace Curb Ramp With Two New Directional Ramps or Equivalent.
