Access Compliance Report

Public Rights-of-Way

(Curb Ramps)

Intersection ID: 14178	Main Street: E_8TH_ST	Cross Street: RIDGEWAY_AV	Location: E
ADA ID: AFCE48594E08	Ramp Type: BlendTrans1	Initial Pass/Fail: Fail	Overall Compliance: No
Severity Score: 1.25			
Codes/Mitigation Info/Possible Solution		Field Measurements/Component Compliance

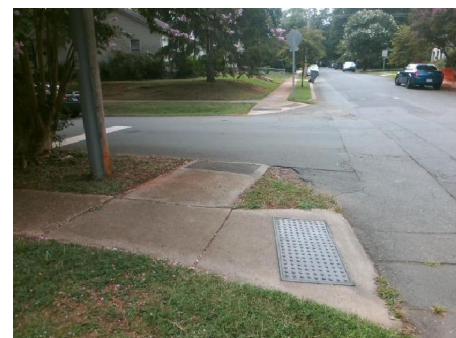
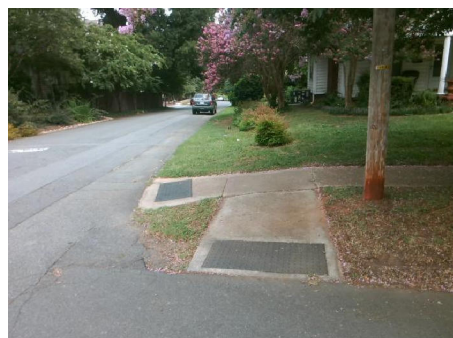
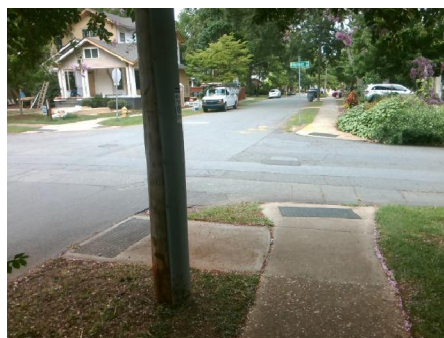
NO CURB LINE

Compliance	Description	Data	Compliance	Description	Data
N/A	Ramp Length (in)	84.0	Yes	BlendTrans Slope (%)	3.3
Yes	Ramp Width (in)	58.0	No	BlendTrans XSlope (%)	4.0
N/A	Flare Type LT	N/A	N/A	Flare Type RT	N/A
N/A	Flare Slope LT (%)	N/A	N/A	Flare Slope RT (%)	N/A
N/A	Flare Traversable LT?	N/A	N/A	Flare Traversable RT?	N/A
N/A	Landing Length (in)	N/A	N/A	DWS Provided?	N/A
N/A	Landing Width (in)	N/A	N/A	DWS Contrast?	N/A
N/A	Landing Slope (%)	N/A	N/A	DWS Length (in)	N/A
N/A	Landing X Slope (%)	N/A	N/A	DWS Full Width?	N/A
N/A	Landing Curb? (Y/N)	N/A	N/A	DWS Offset (in)	N/A
N/A	Shared Landing?	N/A			
N/A	Gutter Ponding?	N/A	N/A	Gutter Slope (%)	N/A
N/A	Gutter Lip Ht (in)	N/A	N/A	Gutter X Slope (%)	N/A
N/A	Painted X Walk1?	No	N/A	Painted X Walk2?	N/A
	X Walk 1 Direction	To SW		X Walk 2 Direction	N/A
	X Walk 1 Width (in)	N/A		X Walk 2 Width (in)	N/A
	X Walk 1 Slope (%)	4.1		X Walk 2 Slope (%)	N/A
	X Walk 1 X Slope (%)	1.1		X Walk 2 X Slope (%)	N/A

N/A	Ramp inside XWalk1?	N/A	N/A	Ramp inside XWalk2?	N/A
	Road Slope (%)	1.1		Clear Space?	N/A
	Road X Slope (%)	4.1	N/A	Clear Space to XWalk (in)	N/A
N/A	Any Obstructions?	N/A	N/A	Storm Grate/Utility Hazard?	N/A
	Obstruction Type			Storm Grate/Utility Type	
		N/A			N/A
			Yes	Surface Condition? (G/P)	Good
			N/A	Curb Slope (%)	N/A

Remove & Replace Curb Ramp With Two New Directional Ramps or Equivalent.
