Access Compliance Report

Public Rights-of-Way

(Curb Ramps)

Intersection ID: 54461	Main Street: FENWAY_DR	Cross Street: FLINT_HILL_DR	Location: SW
ADA ID: AFD8057FF5B1	Ramp Type: Perp	Initial Pass/Fail: Fail	Overall Compliance: No
		Severity Score: 12.5

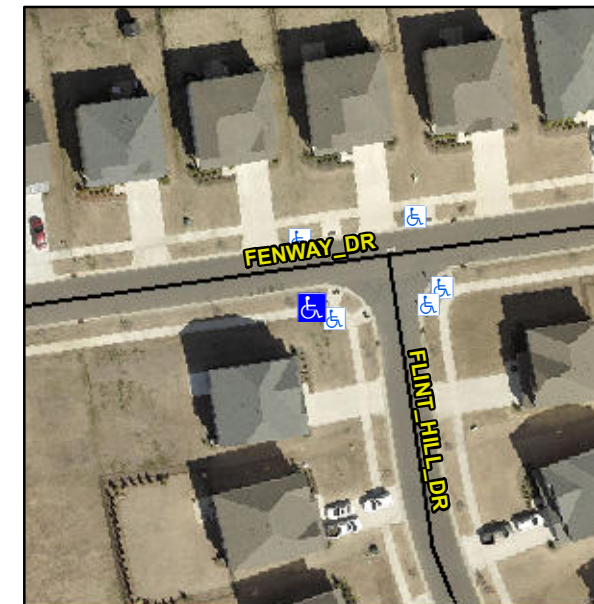
Not Found, R304.2.2

Compliance	Description	Data	Compliance	Description	Data
N/A	Ramp Length (in)	92.0	No	Ramp Slope (%)	9.3
Yes	Ramp Width (in)	48.0	Yes	Ramp XSlope (%)	1.5
N/A	Flare Type LT	N/A	N/A	Flare Type RT	N/A
N/A	Flare Slope LT (%)	N/A	N/A	Flare Slope RT (%)	N/A
N/A	Flare Traversable LT?	N/A	N/A	Flare Traversable RT?	N/A
N/A	Landing Length (in)	N/A	N/A	DWS Provided?	N/A
N/A	Landing Width (in)	N/A	N/A	DWS Contrast?	N/A
N/A	Landing Slope (%)	N/A	N/A	DWS Length (in)	N/A
N/A	Landing X Slope (%)	N/A	N/A	DWS Full Width?	N/A
N/A	Landing Curb? (Y/N)	N/A	N/A	DWS Offset (in)	N/A
N/A	Shared Landing?	N/A			
N/A	Gutter Ponding?	N/A	N/A	Gutter Slope (%)	N/A
N/A	Gutter Lip Ht (in)	1.0	N/A	Gutter X Slope (%)	N/A
N/A	Painted X Walk1?	No	N/A	Painted X Walk2?	N/A
	X Walk 1 Direction	To N		X Walk 2 Direction	N/A
N/A	X Walk 1 Width (in)	N/A	N/A	X Walk 2 Width (in)	N/A
	X Walk 1 Slope (%)	4.0		X Walk 2 Slope (%)	N/A
	X Walk 1 X Slope (%)	1.3		X Walk 2 X Slope (%)	N/A

Remove & Replace Entire Ramp.
