Access Compliance Report

Public Rights-of-Way

(Curb Ramps)

Intersection ID: N/A	Main Street: OLD_PINEVILLE_RD	Cross Street: N/A	Location: SE
ADA ID: AFE47A9C5001	Ramp Type: Perp	Initial Pass/Fail: Pass	Overall Compliance: No
Codes/Mitigation Info/Possible Solution		Field Measurements/Component Compliance	
Severity Score: 2.5

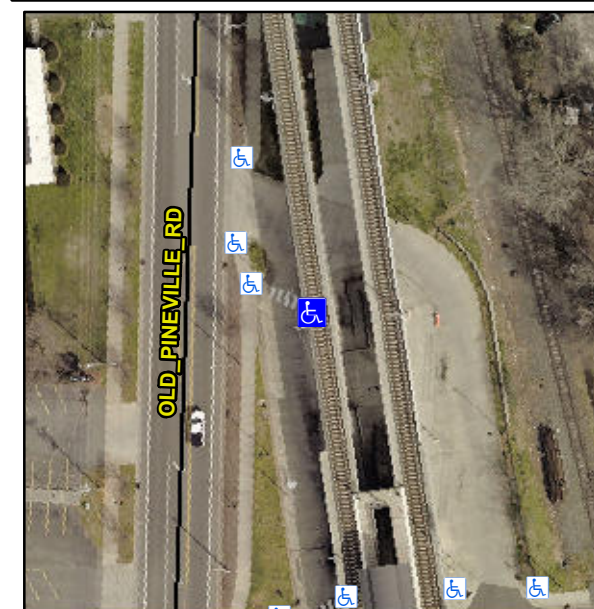
Compliance	Description	Data	Compliance	Description	Data
N/A	Ramp Length (in)	72.5	Yes	Ramp Slope (%)	5.1
Yes	Ramp Width (in)	59.0	Yes	Ramp XSlope (%)	1.4
N/A	Flare Type LT	Sloped	N/A	Flare Type RT	N/A
N/A	Flare Slope LT (%)	8.0	Yes	Flare Slope RT (%)	6.8
N/A	Flare Traversable LT?	Yes	N/A	Flare Traversable RT?	Yes
Yes	Landing Length (in)	52.0	Yes	DWS Provided?	Yes
Yes	Landing Width (in)	49.0	Yes	DWS Contrast?	Yes
Yes	Landing Slope (%)	0.4	Yes	DWS Length (in)	24.0
Yes	Landing X Slope (%)	0.9	No	DWS Full Width?	No
N/A	Landing Curb? (Y/N)	No	Yes	DWS Offset (in)	0.0
N/A	Shared Landing?	No			
Yes	Gutter Ponding?	No	Yes	Gutter Slope (%)	0.3
Yes	Gutter Lip Ht (in)	0.0	Yes	Gutter X Slope (%)	0.7
N/A	Painted X Walk1?	Yes	N/A	Painted X Walk2?	N/A
	X Walk 1 Direction	To NW		X Walk 2 Direction	N/A
N/A	X Walk 1 Width (in)	87.0	N/A	X Walk 2 Width (in)	N/A
	X Walk 1 Slope (%)	3.1		X Walk 2 Slope (%)	N/A
	X Walk 1 X Slope (%)	0.6		X Walk 2 X Slope (%)	N/A

Yes	Ramp inside XWalk1?	Yes	N/A	Ramp inside XWalk2?	N/A
	Road Slope (%)	N/A	N/A	Clear Space?	Yes
	Road X Slope (%)	N/A	N/A	Clear Space to XWalk (in)	N/A
Yes	Any Obstructions?	No	Yes	Storm Grate/Utility Hazard?	No
	Obstruction Type			Storm Grate/Utility Type	
		N/A			N/A
			Yes	Surface Condition? (G/P)	Good

Possible Solutions:

Remove & Replace Detectable Warning System.

R305.1.4
