Access Compliance Report

Public Rights-of-Way

(Curb Ramps)

Intersection ID: 51379	Main Street: BROADRICK_BV	Cross Street: UNIVERSITY_CITY_BV	Location:	N
ADA ID: AFFE2FAE9B75	Ramp Type: Perp	Initial Pass/Fail: Fail	Overall Compliance: No	Severity Score: 25
Codes/Mitigation Info/Possible Solution		Field Measurements/Component Compliance

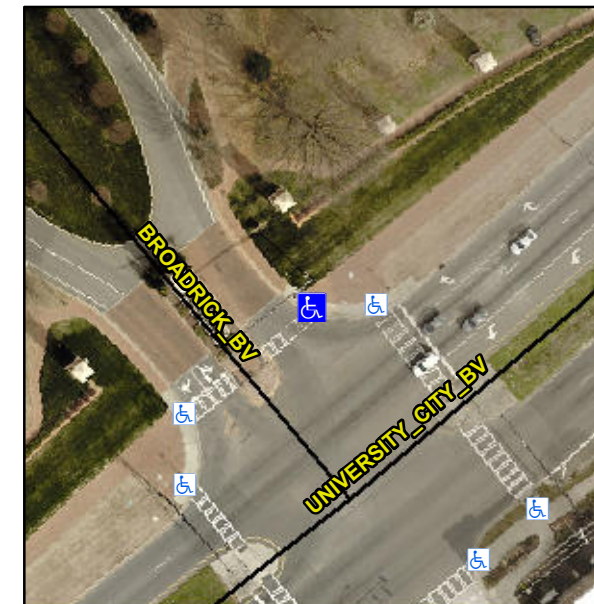
Not Found, R304.2.2

Compliance	Description	Data	Compliance	Description	Data
N/A	Ramp Length (in)	73.0	No	Ramp Slope (%)	20.0
Yes	Ramp Width (in)	52.0	Yes	Ramp XSlope (%)	1.3
N/A	Flare Type LT	N/A	N/A	Flare Type RT	N/A
N/A	Flare Slope LT (%)	N/A	N/A	Flare Slope RT (%)	N/A
N/A	Flare Traversable LT?	N/A	N/A	Flare Traversable RT?	N/A
N/A	Landing Length (in)	N/A	N/A	DWS Provided?	N/A
N/A	Landing Width (in)	N/A	N/A	DWS Contrast?	N/A
N/A	Landing Slope (%)	N/A	N/A	DWS Length (in)	N/A
N/A	Landing X Slope (%)	N/A	N/A	DWS Full Width?	N/A
N/A	Landing Curb? (Y/N)	N/A	N/A	DWS Offset (in)	N/A
N/A	Shared Landing?	N/A			
N/A	Gutter Ponding?	N/A	N/A	Gutter Slope (%)	N/A
N/A	Gutter Lip Ht (in)	N/A	N/A	Gutter X Slope (%)	N/A
N/A	Painted X Walk1?	Yes	N/A	Painted X Walk2?	N/A
	X Walk 1 Direction	To SW		X Walk 2 Direction	N/A
N/A	X Walk 1 Width (in)	75.0	N/A	X Walk 2 Width (in)	N/A
	X Walk 1 Slope (%)	2.3		X Walk 2 Slope (%)	N/A
	X Walk 1 X Slope (%)	0.7		X Walk 2 X Slope (%)	N/A

N/A	Ramp inside XWalk1?	Yes	N/A	Ramp inside XWalk2?	N/A
	Road Slope (%)	N/A	N/A	Clear Space?	N/A
	Road X Slope (%)	N/A	N/A	Clear Space to XWalk (in)	N/A
N/A	Any Obstructions?	N/A	N/A	Storm Grate/Utility Hazard?	N/A
	Obstruction Type			Storm Grate/Utility Type	
		N/A			N/A
			Yes	Surface Condition? (G/P)	Good

Possible Solutions:

Remove & Replace Entire Ramp.

Total Cost: \$ 1850.00
