Access Compliance Report

Public Rights-of-Way

(Curb Ramps)

Intersection ID: 16359	Main Street: FREELAND_LN	Cross Street: SOUTH_BV	Location: NW
ADA ID: B0013439151D	Ramp Type: PerpDiag	Initial Pass/Fail: Fail	Overall Compliance: No Severity Score: 13.75

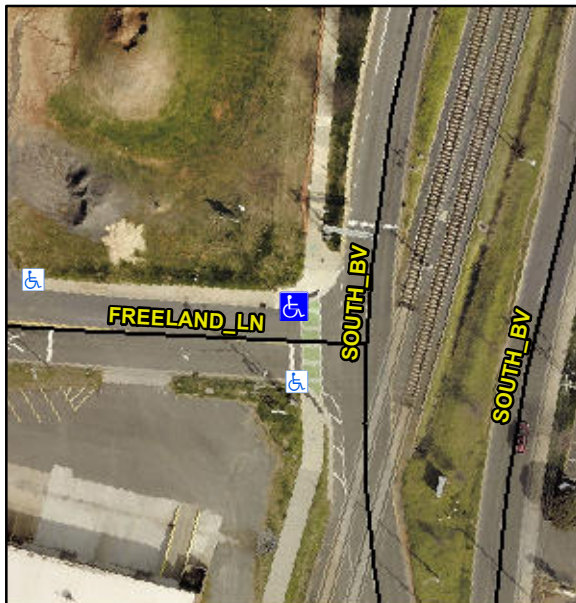
Compliance	Description	Data	Compliance	Description	Data
N/A	Ramp Length (in)	60.0	No	Ramp Slope (%)	8.6
Yes	Ramp Width (in)	119.0	No	Ramp XSlope (%)	4.3
N/A	Flare Type LT	N/A	N/A	Flare Type RT	N/A
N/A	Flare Slope LT (%)	N/A	N/A	Flare Slope RT (%)	N/A
N/A	Flare Traversable LT?	N/A	N/A	Flare Traversable RT?	N/A
N/A	Landing Length (in)	N/A	N/A	DWS Provided?	N/A
N/A	Landing Width (in)	N/A	N/A	DWS Contrast?	N/A
N/A	Landing Slope (%)	N/A	N/A	DWS Length (in)	N/A
N/A	Landing X Slope (%)	N/A	N/A	DWS Full Width?	N/A
N/A	Landing Curb? (Y/N)	N/A	N/A	DWS Offset (in)	N/A
N/A	Shared Landing?	N/A			
N/A	Gutter Ponding?	N/A	N/A	Gutter Slope (%)	N/A
N/A	Gutter Lip Ht (in)	N/A	N/A	Gutter X Slope (%)	N/A
N/A	Painted X Walk1?	Yes	N/A	Painted X Walk2?	No
	X Walk 1 Direction	To S		X Walk 2 Direction	To E
N/A	X Walk 1 Width (in)	106.0	N/A	X Walk 2 Width (in)	N/A
	X Walk 1 Slope (%)	0.2		X Walk 2 Slope (%)	2.5
	X Walk 1 X Slope (%)	4.1		X Walk 2 X Slope (%)	0.0

N/A	Ramp inside XWalk1?	Yes	N/A	Ramp inside XWalk2?	N/A
	Road Slope (%)	0.7	N/A	Clear Space?	N/A
	Road X Slope (%)	0.8	N/A	Clear Space to XWalk (in)	N/A
N/A	Any Obstructions?	N/A	N/A	Storm Grate/Utility Hazard?	N/A
	Obstruction Type			Storm Grate/Utility Type	
		N/A			N/A
		Yes		Surface Condition? (G/P)	Good

Remove & Replace Curb Ramp With Two New Directional Ramps or Equivalent.

R304.2.2, R304.5.3
