Access Compliance Report

Public Rights-of-Way

(Curb Ramps)

Intersection ID: 10079	Main Street: GASTON_ST	Cross Street: TUCKASEEGEE_RD	Location: SW
ADA ID: B00430E07189	Ramp Type: BlendTrans2	Initial Pass/Fail: Fail	Overall Compliance: No
		Severity Score: 1.25

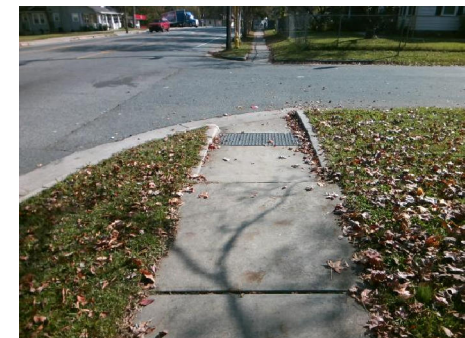
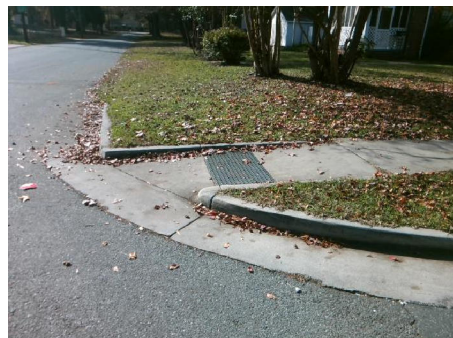
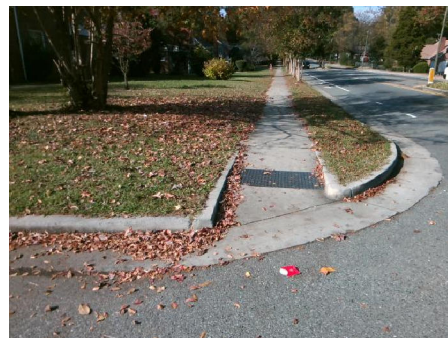
Compliance	Description	Data	Compliance	Description	Data
N/A	Ramp Length (in)	89.0	Yes	BlendTrans Slope (%)	4.0
Yes	Ramp Width (in)	48.0	No	BlendTrans XSlope (%)	2.2
N/A	Flare Type LT	N/A	N/A	Flare Type RT	N/A
N/A	Flare Slope LT (%)	N/A	N/A	Flare Slope RT (%)	N/A
N/A	Flare Traversable LT?	N/A	N/A	Flare Traversable RT?	N/A
N/A	Landing Length (in)	N/A	N/A	DWS Provided?	N/A
N/A	Landing Width (in)	N/A	N/A	DWS Contrast?	N/A
N/A	Landing Slope (%)	N/A	N/A	DWS Length (in)	N/A
N/A	Landing X Slope (%)	N/A	N/A	DWS Full Width?	N/A
N/A	Landing Curb? (Y/N)	N/A	N/A	DWS Offset (in)	N/A
N/A	Shared Landing?	N/A			
N/A	Gutter Ponding?	N/A	N/A	Gutter Slope (%)	N/A
N/A	Gutter Lip Ht (in)	N/A	N/A	Gutter X Slope (%)	N/A
N/A	Painted X Walk1?	No	N/A	Painted X Walk2?	N/A
	X Walk 1 Direction	To E		X Walk 2 Direction	N/A
	X Walk 1 Width (in)	N/A		X Walk 2 Width (in)	N/A
	X Walk 1 Slope (%)	1.6		X Walk 2 Slope (%)	N/A
	X Walk 1 X Slope (%)	1.3		X Walk 2 X Slope (%)	N/A

N/A	Ramp inside XWalk1?	N/A	N/A	Ramp inside XWalk2?	N/A
	Road Slope (%)	1.3		Clear Space?	N/A
	Road X Slope (%)	1.6	N/A	Clear Space to XWalk (in)	N/A
N/A	Any Obstructions?	N/A	N/A	Storm Grate/Utility Hazard?	N/A
	Obstruction Type			Storm Grate/Utility Type	
		N/A			N/A
			Yes	Surface Condition? (G/P)	Good
			N/A	Curb Slope (%)	0.4

Remove & Replace Curb Ramp With Two New Directional Ramps or Equivalent.

R304.5.3
