# Access Compliance Report

## Public Rights-of-Way (Curb Ramps)

| Intersection ID: 10756 | Main Street: GALWAY_DR | Cross Street: SHANNONHOUSE_DR | Location: NW |
| ADA ID: B00CCDF52B80 | Ramp Type: Perp | Initial Pass/Fail: Pass | Overall Compliance: No |

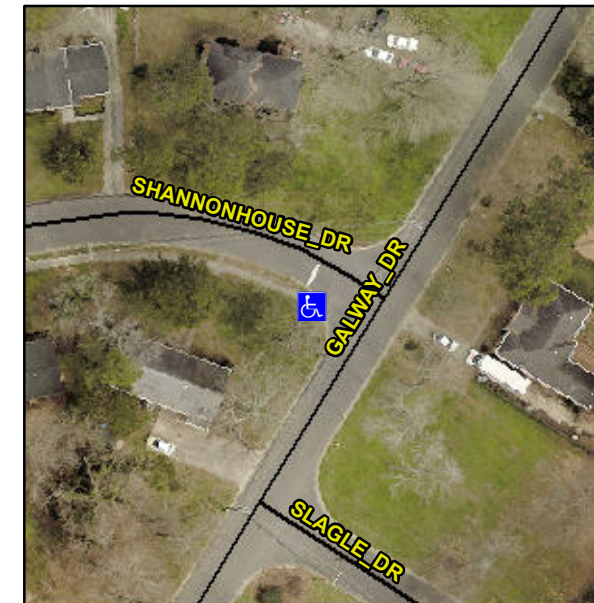
**Not Found, R304.2.1, R304.2.2-Perp,  
R304.3.2-Para, R305.1.4, R305.2,  
R304.5.4**

| Compliance | Description | Data | Compliance | Description | Data |
|---|---|---|---|---|---|
| No | Landing Length (in) | 33.0 | Yes | DWS Provided? | Yes |
| No | Landing Slope (%) | 3.5 | Yes | DWS Length (in) | 24.0 |
| Yes | Landing X Slope (%) | 0.2 | No | DWS Full Width? | No |
| N/A | Landing Curb? (Y/N) | No | No | DWS Offset (in) | 4.0 |
| Yes | Gutter Ponding? | No | No | Gutter Slope (%) | 5.7 |

**Remove & Replace Entire Ramp.  
Remove & Replace Gutter.**

Total Cost: \$ 2600.00
