# Access Compliance Report

## Public Rights-of-Way (Curb Ramps)

Intersection ID: 32022	Main Street: FAIRWAY_VISTA_DR	Cross Street: GREENWAY_BEND_DR	Location: S
ADA ID: B00FAB64B0FA	Ramp Type: Perp	Initial Pass/Fail: Fail	Overall Compliance: No
Codes/Mitigation Info/Possible Solution		Field Measurements/Component Compliance	
Severity Score: 25

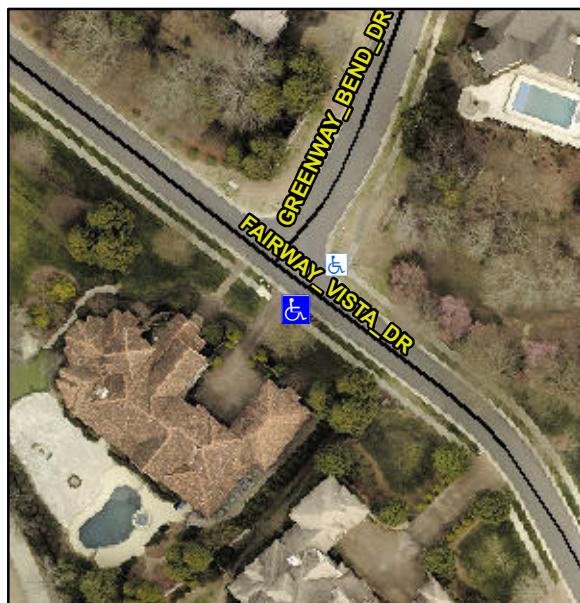
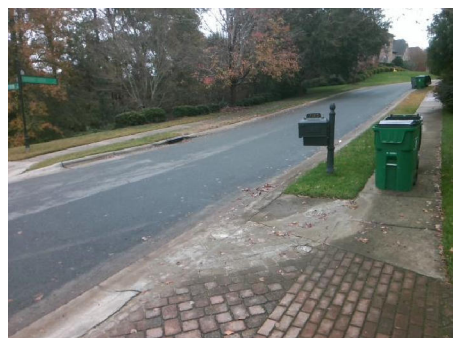
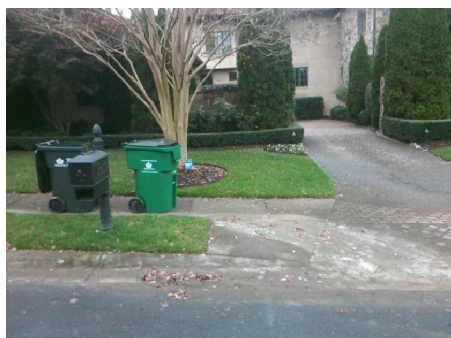
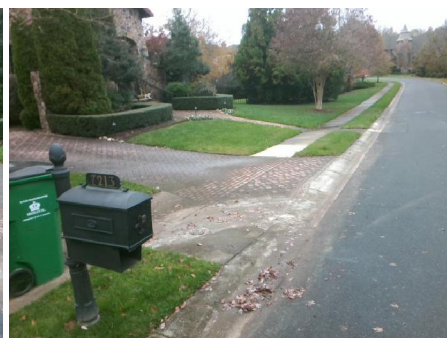
**Not Found, R304.5.3**

Compliance	Description	Data	Compliance	Description	Data
N/A	Ramp Length (in)	49.0	Yes	Ramp Slope (%)	5.6
Yes	Ramp Width (in)	49.0	No	Ramp XSlope (%)	10.8
N/A	Flare Type LT	N/A	N/A	Flare Type RT	N/A
N/A	Flare Slope LT (%)	N/A	N/A	Flare Slope RT (%)	N/A
N/A	Flare Traversable LT?	N/A	N/A	Flare Traversable RT?	N/A
N/A	Landing Length (in)	N/A	N/A	DWS Provided?	N/A
N/A	Landing Width (in)	N/A	N/A	DWS Contrast?	N/A
N/A	Landing Slope (%)	N/A	N/A	DWS Length (in)	N/A
N/A	Landing X Slope (%)	N/A	N/A	DWS Full Width?	N/A
N/A	Landing Curb? (Y/N)	N/A	N/A	DWS Offset (in)	N/A
N/A	Shared Landing?	N/A			
N/A	Gutter Ponding?	N/A	N/A	Gutter Slope (%)	N/A
N/A	Gutter Lip Ht (in)	N/A	N/A	Gutter X Slope (%)	N/A
N/A	Painted X Walk1?	No	N/A	Painted X Walk2?	N/A
	X Walk 1 Direction	To NE		X Walk 2 Direction	N/A
N/A	X Walk 1 Width (in)	N/A	N/A	X Walk 2 Width (in)	N/A
	X Walk 1 Slope (%)	2.6		X Walk 2 Slope (%)	N/A
	X Walk 1 X Slope (%)	7.5		X Walk 2 X Slope (%)	N/A

N/A	Ramp inside XWalk1?	N/A	N/A	Ramp inside XWalk2?	N/A
	Road Slope (%)	N/A	N/A	Clear Space?	N/A
	Road X Slope (%)	N/A	N/A	Clear Space to XWalk (in)	N/A
N/A	Any Obstructions?	N/A	N/A	Storm Grate/Utility Hazard?	N/A
	Obstruction Type			Storm Grate/Utility Type	
		N/A			N/A
			Yes	Surface Condition? (G/P)	Good

**Remove & Replace Entire Ramp.**
