Access Compliance Report

Public Rights-of-Way

(Curb Ramps)

Intersection ID: 29352	Main Street: OSAGE_CR	Cross Street: OSAGE_CR	Location: SW
ADA ID: B012E89845DF	Ramp Type: PerpDiag	Initial Pass/Fail: Fail	Overall Compliance: No
Severity Score: 8.75			
Codes/Mitigation Info/Possible Solution		Field Measurements/Component Compliance

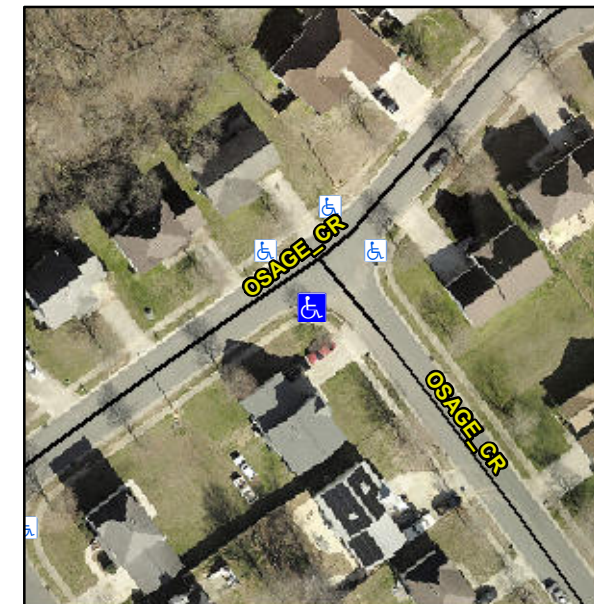
Compliance	Description	Data	Compliance	Description	Data
N/A	Ramp Length (in)	49.0	Yes	Ramp Slope (%)	6.0
No	Ramp Width (in)	44.0	Yes	Ramp XSlope (%)	2.0
N/A	Flare Type LT	N/A	N/A	Flare Type RT	N/A
N/A	Flare Slope LT (%)	N/A	N/A	Flare Slope RT (%)	N/A
N/A	Flare Traversable LT?	N/A	N/A	Flare Traversable RT?	N/A
N/A	Landing Length (in)	N/A	N/A	DWS Provided?	N/A
N/A	Landing Width (in)	N/A	N/A	DWS Contrast?	N/A
N/A	Landing Slope (%)	N/A	N/A	DWS Length (in)	N/A
N/A	Landing X Slope (%)	N/A	N/A	DWS Full Width?	N/A
N/A	Landing Curb? (Y/N)	N/A	N/A	DWS Offset (in)	N/A
N/A	Shared Landing?	N/A			
N/A	Gutter Ponding?	N/A	N/A	Gutter Slope (%)	N/A
N/A	Gutter Lip Ht (in)	1.0	N/A	Gutter X Slope (%)	N/A
N/A	Painted X Walk1?	No	N/A	Painted X Walk2?	No
	X Walk 1 Direction	To NE		X Walk 2 Direction	To NW
N/A	X Walk 1 Width (in)	N/A	N/A	X Walk 2 Width (in)	N/A
	X Walk 1 Slope (%)	0.2		X Walk 2 Slope (%)	2.3
	X Walk 1 X Slope (%)	1.3		X Walk 2 X Slope (%)	0.9

N/A	Ramp inside XWalk1?	N/A	N/A	Ramp inside XWalk2?	N/A
	Road Slope (%)	2.2	N/A	Clear Space?	N/A
	Road X Slope (%)	5.3	N/A	Clear Space to XWalk (in)	N/A
N/A	Any Obstructions?	N/A	N/A	Storm Grate/Utility Hazard?	N/A
	Obstruction Type			Storm Grate/Utility Type	
		N/A			N/A
			Yes	Surface Condition? (G/P)	Good

Possible Solutions:

Remove & Replace Curb Ramp With Two New Directional Ramps or Equivalent.
