# Access Compliance Report

## Public Rights-of-Way

### (Curb Ramps)

Intersection ID: 11980	Main Street: ALLEN_ST	Cross Street: E_17TH_ST	Location: NE
ADA ID: B018642CE93E	Ramp Type: Directional1	Initial Pass/Fail: Pass	Overall Compliance: No
Severity Score: 0			
Codes/Mitigation Info/Possible Solution		Field Measurements/Component Compliance

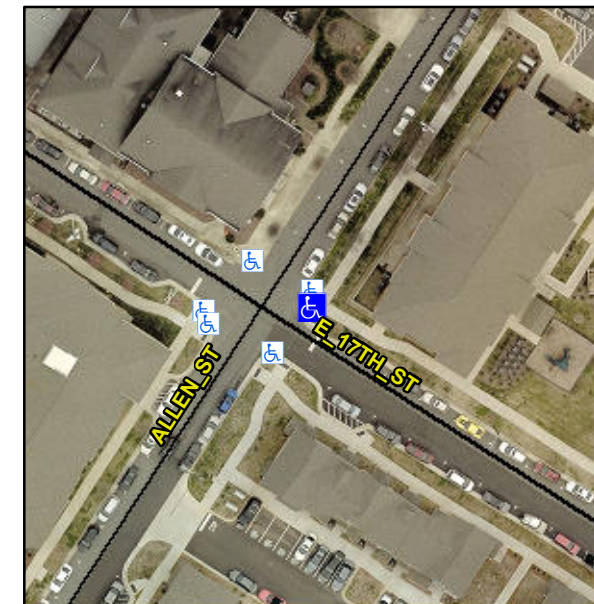
Compliance	Description	Data	Compliance	Description	Data
N/A	Ramp Length (in)	88.0	Yes	Grade Break?	Yes
Yes	Ramp Width (in)	69.0	Yes	Grade Break Slope (%)	3.1
Yes	Ramp Slope (%)	4.2	No	Grade Break XSlope (%)	5.8
Yes	Ramp XSlope (%)	1.9			
Yes	Flare Type LT	N/A	Yes	Flare Type RT	N/A
N/A	Flare Slope LT (%)	N/A	N/A	Flare Slope RT (%)	N/A
N/A	Flare Traversable LT?	No	N/A	Flare Traversable RT?	No
Yes	Landing Length (in)	72.0	Yes	DWS Provided?	Yes
Yes	Landing Width (in)	71.0	Yes	DWS Contrast?	Yes
Yes	Landing Slope (%)	0.0	Yes	DWS Length (in)	24.0
Yes	Landing X Slope (%)	0.1	Yes	DWS Full Width?	Yes
N/A	Landing Curb? (Y/N)	No	Yes	DWS Offset LT (in)	2.0
N/A	Shared Landing?	Yes	Yes	DWS Offset RT (in)	14.0
No	Gutter Ponding?	Yes	Yes	Gutter Slope (%)	2.7
Yes	Gutter Lip Ht (in)	0.0	No	Gutter X Slope (%)	4.9
N/A	Painted X Walk1?	No		Road Slope (%)	4.6
	X Walk 1 Direction	To S		Road X Slope (%)	5.6
	X Walk 1 Width (in)	N/A		Clear Space?	Yes

X Walk 1 Slope (%)	4.6	N/A	Clear Space to XWalk (in)	N/A
	X Walk 1 X Slope (%)	5.6	Yes	Storm Grate/Utility Hazard?	No
N/A	Ramp inside XWalk1?	N/A		Storm Grate/Utility Type	
Yes	Any Obstructions?	No			N/A
	Obstruction Type		Yes	Surface Condition? (G/P)	Good
			N/A	Curb Slope (%)	6.4

Possible Solutions:

**Remove & Replace Entire Ramp.  
Remove & Replace Gutter.**

**R304.5.3, R302.7**

Total Cost: \$ 2350.00
