# Access Compliance Report

## Public Rights-of-Way

### (Curb Ramps)

| Intersection ID: 27384 | Main Street: DOVEHUNT_PL | Cross Street: VALLEY_SPRING_DR | Location: | N |

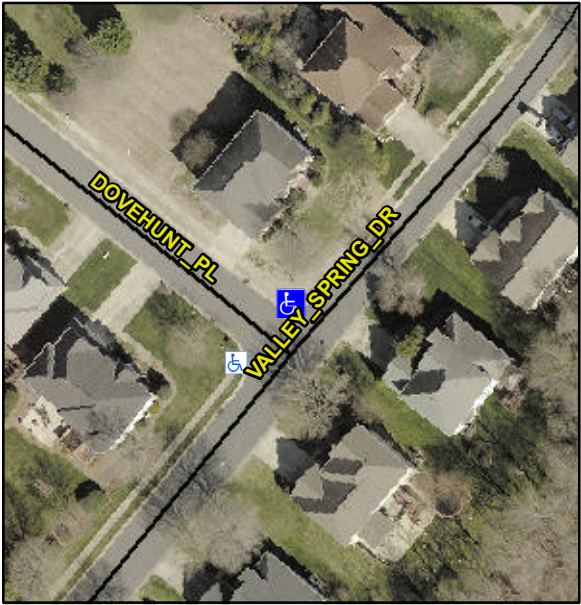
| ADA ID: B01C43F9B1EB | Ramp Type: PerpDiag | Initial Pass/Fail: Fail | Overall Compliance: No | Severity Score: 25 |

| Codes/Mitigation Info/Possible Solution | | | Field Measurements/Component Compliance | | |
|---|---|---|---|---|---|
| <p>Surveyor Notes:</p> <p><b>N/A</b></p> <p>PROW/ADA:</p> <p><b>Not Found, R304.5.3</b></p> | | | N/A | Flare Type RT | N/A |
| | | | | X Walk 1 Slope (%) | 8.6 |
| | | | | X Walk 1 X Slope (%) | 4.0 |
| | | | | Road Slope (%) | 9.2 |

| Codes/Mitigation Info/Possible Solution | | | Field Measurements/Component Compliance | | |
|---|---|---|---|---|---|
| | <b>Remove &amp; Replace Curb Ramp With Two New Directional Ramps or Equivalent.</b> | | N/A | Ramp Length (in) | 46.0 |
