Access Compliance Report

Public Rights-of-Way

(Curb Ramps)

Intersection ID: 10025024	Main Street: DONNELLSON_COMMON_CT	Cross Street: N/A	Location:	N/A
ADA ID: B01F61534757	Ramp Type: Perp	Initial Pass/Fail: Fail	Overall Compliance: No	Severity Score: 17.5
Codes/Mitigation Info/Possible Solution			Field Measurements/Component Compliance

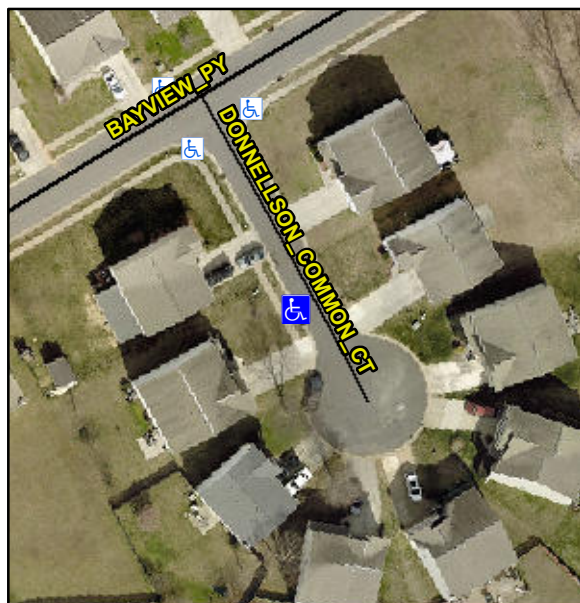
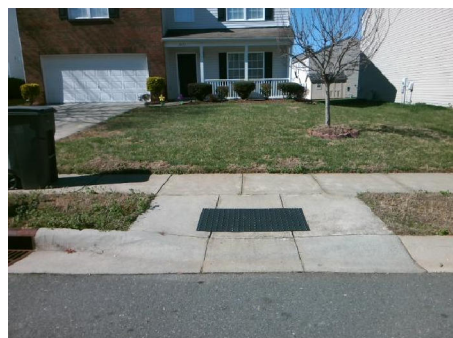
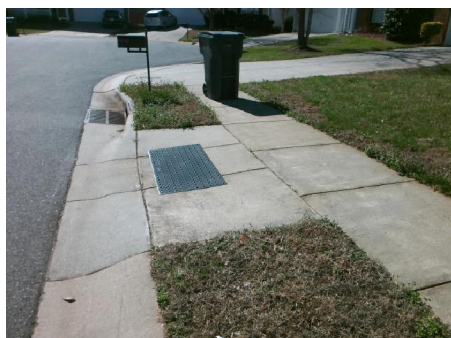
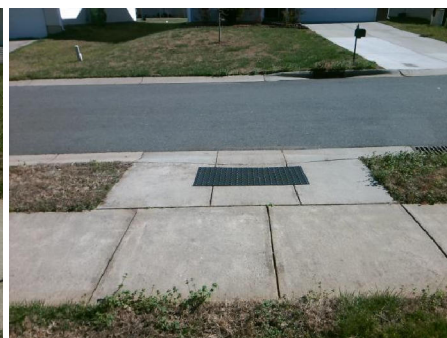
Not Found, R304.5.1

Compliance	Description	Data	Compliance	Description	Data
N/A	Ramp Length (in)	48.0	Yes	Ramp Slope (%)	8.3
No	Ramp Width (in)	32.0	Yes	Ramp XSlope (%)	0.4
N/A	Flare Type LT	N/A	N/A	Flare Type RT	N/A
N/A	Flare Slope LT (%)	N/A	N/A	Flare Slope RT (%)	N/A
N/A	Flare Traversable LT?	N/A	N/A	Flare Traversable RT?	N/A
N/A	Landing Length (in)	N/A	N/A	DWS Provided?	N/A
N/A	Landing Width (in)	N/A	N/A	DWS Contrast?	N/A
N/A	Landing Slope (%)	N/A	N/A	DWS Length (in)	N/A
N/A	Landing X Slope (%)	N/A	N/A	DWS Full Width?	N/A
N/A	Landing Curb? (Y/N)	N/A	N/A	DWS Offset (in)	N/A
N/A	Shared Landing?	N/A			
N/A	Gutter Ponding?	N/A	N/A	Gutter Slope (%)	N/A
N/A	Gutter Lip Ht (in)	N/A	N/A	Gutter X Slope (%)	N/A
N/A	Painted X Walk1?	No	N/A	Painted X Walk2?	N/A
	X Walk 1 Direction	To E		X Walk 2 Direction	N/A
N/A	X Walk 1 Width (in)	N/A	N/A	X Walk 2 Width (in)	N/A
	X Walk 1 Slope (%)	1.3		X Walk 2 Slope (%)	N/A
	X Walk 1 X Slope (%)	3.1		X Walk 2 X Slope (%)	N/A

N/A	Ramp inside XWalk1?	N/A	N/A	Ramp inside XWalk2?	N/A
	Road Slope (%)	3.1	N/A	Clear Space?	N/A
	Road X Slope (%)	1.3	N/A	Clear Space to XWalk (in)	N/A
N/A	Any Obstructions?	N/A	N/A	Storm Grate/Utility Hazard?	N/A
	Obstruction Type			Storm Grate/Utility Type	
		N/A			N/A
			Yes	Surface Condition? (G/P)	Good

Remove & Replace Entire Ramp.

Total Cost: \$ 1850.00
