# Access Compliance Report

## Public Rights-of-Way

### (Curb Ramps)

Intersection ID: 13389	Main Street: ELIZABETH_AV	Cross Street: N_KINGS_DR	Location: S
ADA ID: B029FA51C8E0	Ramp Type: Perp	Initial Pass/Fail: Fail	Overall Compliance: No
Severity Score: 8.75			
Codes/Mitigation Info/Possible Solution		Field Measurements/Component Compliance

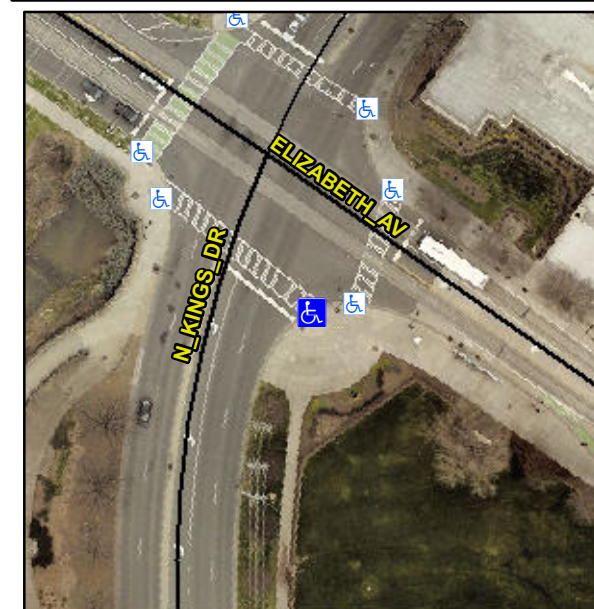
**Not Found, R304.5.1**

Compliance	Description	Data	Compliance	Description	Data
N/A	Ramp Length (in)	72.5	Yes	Ramp Slope (%)	5.1
No	Ramp Width (in)	43.0	Yes	Ramp XSlope (%)	1.3
N/A	Flare Type LT	N/A	N/A	Flare Type RT	N/A
N/A	Flare Slope LT (%)	N/A	N/A	Flare Slope RT (%)	N/A
N/A	Flare Traversable LT?	N/A	N/A	Flare Traversable RT?	N/A
N/A	Landing Length (in)	N/A	N/A	DWS Provided?	N/A
N/A	Landing Width (in)	N/A	N/A	DWS Contrast?	N/A
N/A	Landing Slope (%)	N/A	N/A	DWS Length (in)	N/A
N/A	Landing X Slope (%)	N/A	N/A	DWS Full Width?	N/A
N/A	Landing Curb? (Y/N)	N/A	N/A	DWS Offset (in)	N/A
N/A	Shared Landing?	N/A			
N/A	Gutter Ponding?	N/A	N/A	Gutter Slope (%)	N/A
N/A	Gutter Lip Ht (in)	N/A	N/A	Gutter X Slope (%)	N/A
N/A	Painted X Walk1?	Yes	N/A	Painted X Walk2?	N/A
	X Walk 1 Direction	To NW		X Walk 2 Direction	N/A
N/A	X Walk 1 Width (in)	112.0	N/A	X Walk 2 Width (in)	N/A
	X Walk 1 Slope (%)	0.5		X Walk 2 Slope (%)	N/A
	X Walk 1 X Slope (%)	0.9		X Walk 2 X Slope (%)	N/A

N/A	Ramp inside XWalk1?	Yes	N/A	Ramp inside XWalk2?	N/A
	Road Slope (%)	N/A	N/A	Clear Space?	N/A
	Road X Slope (%)	N/A	N/A	Clear Space to XWalk (in)	N/A
N/A	Any Obstructions?	N/A	N/A	Storm Grate/Utility Hazard?	N/A
	Obstruction Type			Storm Grate/Utility Type	
		N/A			N/A
			Yes	Surface Condition? (G/P)	Good

**Remove & Replace Entire Ramp.**

Total Cost: \$ 1850.00
