# Access Compliance Report

## Public Rights-of-Way

### (Curb Ramps)

Intersection ID: 50326	Main Street: THOREAU_CT	Cross Street: SHARPES_CR	Location: SE
ADA ID: B0319DC61FA8	Ramp Type: PerpDiag	Initial Pass/Fail: Fail	Overall Compliance: No
Severity Score: 10			
Codes/Mitigation Info/Possible Solution		Field Measurements/Component Compliance

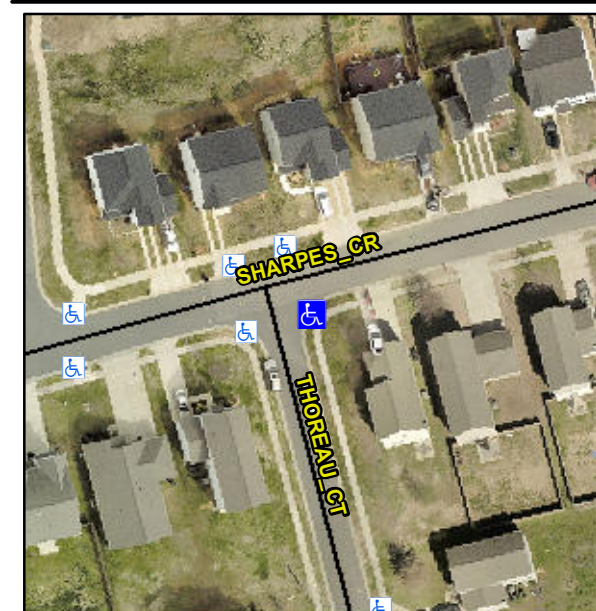
**Not Found, R304.5.1, R304.5.3**

Compliance	Description	Data	Compliance	Description	Data
N/A	Ramp Length (in)	46.0	Yes	Ramp Slope (%)	6.0
No	Ramp Width (in)	47.5	No	Ramp XSlope (%)	2.5
N/A	Flare Type LT	N/A	N/A	Flare Type RT	N/A
N/A	Flare Slope LT (%)	N/A	N/A	Flare Slope RT (%)	N/A
N/A	Flare Traversable LT?	N/A	N/A	Flare Traversable RT?	N/A
N/A	Landing Length (in)	N/A	N/A	DWS Provided?	N/A
N/A	Landing Width (in)	N/A	N/A	DWS Contrast?	N/A
N/A	Landing Slope (%)	N/A	N/A	DWS Length (in)	N/A
N/A	Landing X Slope (%)	N/A	N/A	DWS Full Width?	N/A
N/A	Landing Curb? (Y/N)	N/A	N/A	DWS Offset (in)	N/A
N/A	Shared Landing?	N/A			
N/A	Gutter Ponding?	N/A	N/A	Gutter Slope (%)	N/A
N/A	Gutter Lip Ht (in)	N/A	N/A	Gutter X Slope (%)	N/A
N/A	Painted X Walk1?	No	N/A	Painted X Walk2?	No
	X Walk 1 Direction	To N		X Walk 2 Direction	To W
N/A	X Walk 1 Width (in)	N/A	N/A	X Walk 2 Width (in)	N/A
	X Walk 1 Slope (%)	6.5		X Walk 2 Slope (%)	2.5
	X Walk 1 X Slope (%)	1.3		X Walk 2 X Slope (%)	5.2

N/A	Ramp inside XWalk1?	N/A	N/A	Ramp inside XWalk2?	N/A
	Road Slope (%)	5.0	N/A	Clear Space?	N/A
	Road X Slope (%)	4.5	N/A	Clear Space to XWalk (in)	N/A
N/A	Any Obstructions?	N/A	N/A	Storm Grate/Utility Hazard?	N/A
	Obstruction Type			Storm Grate/Utility Type	
		N/A			N/A
		Yes		Surface Condition? (G/P)	Good

**Remove & Replace Curb Ramp With Two New Directional Ramps or Equivalent.**
