# Access Compliance Report

## Public Rights-of-Way

### (Curb Ramps)

| Intersection ID: 8323 | Main Street: JENNINGS_ST | Cross Street: CATHERINE_SIMMONS_AV | Location: NW |

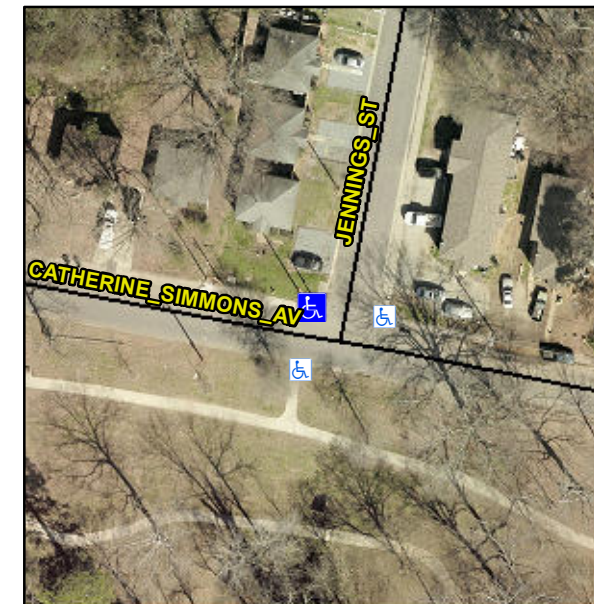
| Severity Score: 2.75 | | | |

**NO CURB LINE**

**R304.5.3, R305.1.4, R305.2**

| Compliance | Description | Data | Compliance | Description | Data |
|---|---|---|---|---|---|
| Yes | Ramp Width (in) | 96.0 | No | BlendTrans XSlope (%) | 3.8 |
| N/A | Landing X Slope (%) | N/A | No | DWS Full Width? | No |
| N/A | Landing Curb? (Y/N) | No | No | DWS Offset (in) | 5.0 |
| Yes | Gutter Lip Ht (in) | 0.0 | No | Gutter X Slope (%) | 2.4 |

**Remove & Replace Curb Ramp With Two New Directional Ramps or Equivalent. Remove & Replace Gutter.**

Total Cost: \$ 3950.00
