# Access Compliance Report

## Public Rights-of-Way

### (Curb Ramps)

| Intersection ID: 8508 | Main Street: W_SUGAR_CREEK_RD | Cross Street: GLORY_ST | Location: SW |

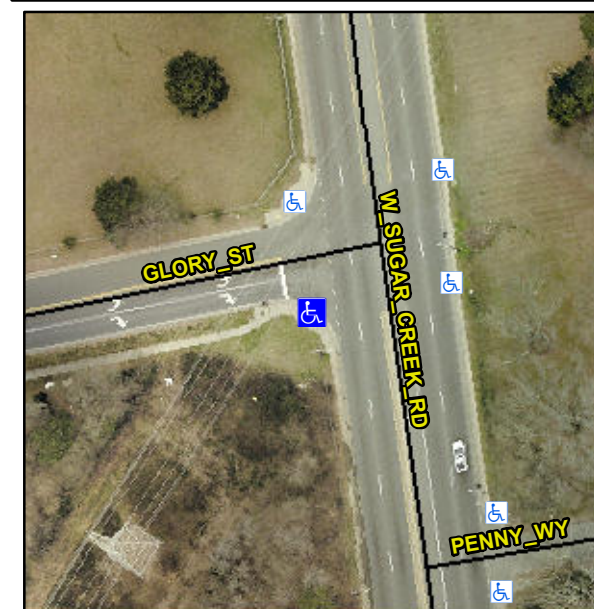
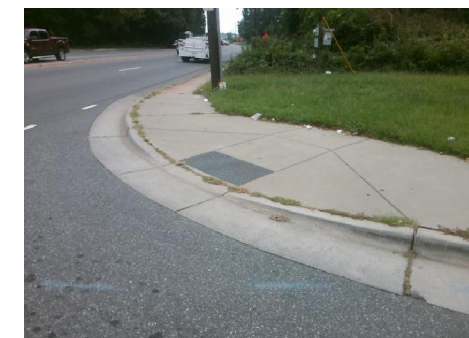
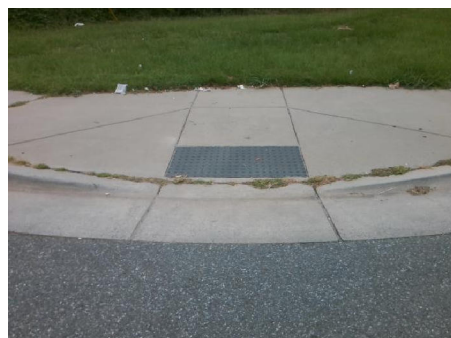
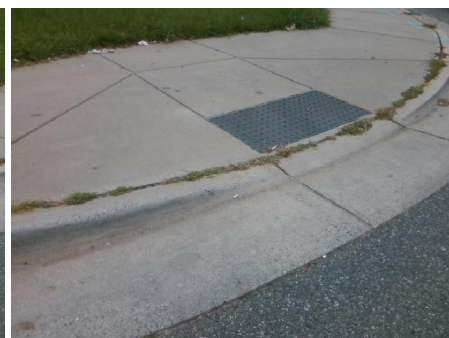
**Not Found, R304.2.1, R304.5.3, R304.2.3, R305.2**

| Compliance | Description | Data | Compliance | Description | Data |
|---|---|---|---|---|---|
| N/A | Flare Slope LT (%) | 4.8 | No | Flare Slope RT (%) | 10.4 |
| No | Landing Length (in) | 47.0 | Yes | DWS Provided? | Yes |
| No | Landing X Slope (%) | 3.8 | Yes | DWS Full Width? | Yes |
| N/A | Landing Curb? (Y/N) | No | No | DWS Offset (in) | 3.5 |
| Yes | Gutter Lip Ht (in) | 0.0 | No | Gutter X Slope (%) | 2.2 |

**Remove & Replace Curb Ramp With Two New Directional Ramps or Equivalent. Remove & Replace Gutter.**
