# Access Compliance Report

## Public Rights-of-Way

### (Curb Ramps)

Intersection ID: 15596	Main Street: ARDMORE_RD	Cross Street: LAWNDAL RD	Location: NW
ADA ID: B03AA71D5DD6	Ramp Type: PerpDiag	Initial Pass/Fail: Fail	Overall Compliance: No
			Severity Score: 28.75

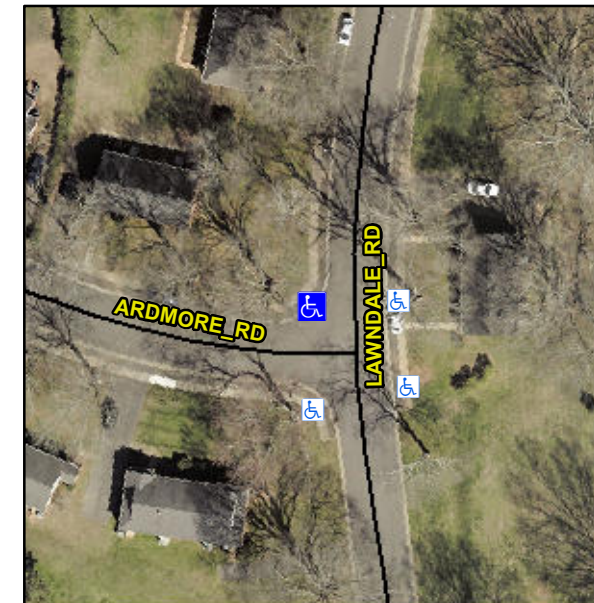
**Not Found, R304.2.2, R304.5.3, R302.7**

Compliance	Description	Data	Compliance	Description	Data
N/A	Ramp Length (in)	106.5	No	Ramp Slope (%)	11.6
Yes	Ramp Width (in)	48.0	No	Ramp XSlope (%)	3.9
N/A	Flare Type LT	N/A	N/A	Flare Type RT	N/A
N/A	Flare Slope LT (%)	N/A	N/A	Flare Slope RT (%)	N/A
N/A	Flare Traversable LT?	N/A	N/A	Flare Traversable RT?	N/A
N/A	Landing Length (in)	N/A	N/A	DWS Provided?	N/A
N/A	Landing Width (in)	N/A	N/A	DWS Contrast?	N/A
N/A	Landing Slope (%)	N/A	N/A	DWS Length (in)	N/A
N/A	Landing X Slope (%)	N/A	N/A	DWS Full Width?	N/A
N/A	Landing Curb? (Y/N)	N/A	N/A	DWS Offset (in)	N/A
N/A	Shared Landing?	N/A			
N/A	Gutter Ponding?	N/A	N/A	Gutter Slope (%)	N/A
N/A	Gutter Lip Ht (in)	N/A	N/A	Gutter X Slope (%)	N/A
N/A	Painted X Walk1?	No	N/A	Painted X Walk2?	No
	X Walk 1 Direction	To S		X Walk 2 Direction	To E
N/A	X Walk 1 Width (in)	N/A	N/A	X Walk 2 Width (in)	N/A
	X Walk 1 Slope (%)	5.6		X Walk 2 Slope (%)	3.2
	X Walk 1 X Slope (%)	0.5		X Walk 2 X Slope (%)	3.8

N/A	Ramp inside XWalk1?	N/A	N/A	Ramp inside XWalk2?	N/A
	Road Slope (%)	1.9	N/A	Clear Space?	N/A
	Road X Slope (%)	5.6	N/A	Clear Space to XWalk (in)	N/A
N/A	Any Obstructions?	N/A	N/A	Storm Grate/Utility Hazard?	N/A
	Obstruction Type			Storm Grate/Utility Type	
		N/A			N/A
		No		Surface Condition? (G/P)	Poor

**Remove & Replace Curb Ramp With Two New Directional Ramps or Equivalent.**
