# Access Compliance Report

## Public Rights-of-Way

### (Curb Ramps)

Intersection ID: 7848	Main Street: KENDALL_DR	Cross Street: SENIOR_DR	Location: SE
ADA ID: B03D1BE83901	Ramp Type: Perp	Initial Pass/Fail: Fail	Overall Compliance: No
Severity Score: 1.25			
Codes/Mitigation Info/Possible Solution		Field Measurements/Component Compliance

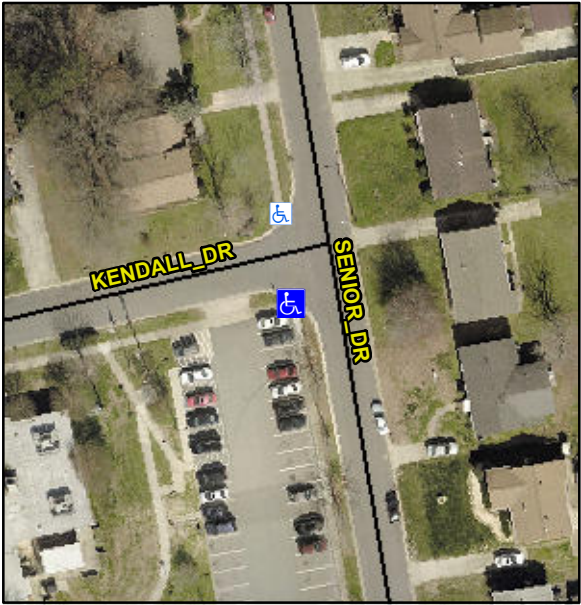
Possible Solutions:						
	Remove & Replace Entire Ramp.						
	Surveyor Notes:  <b>N/A</b>	Compliance	Description	Data	Compliance	Description	Data
		N/A	Ramp Length (in)	25.5	Yes	Ramp Slope (%)	6.1
		Yes	Ramp Width (in)	48.0	No	Ramp XSlope (%)	2.9
		N/A	Flare Type LT	N/A	N/A	Flare Type RT	N/A
		N/A	Flare Slope LT (%)	N/A	N/A	Flare Slope RT (%)	N/A
		N/A	Flare Traversable LT?	N/A	N/A	Flare Traversable RT?	N/A
		N/A	Landing Length (in)	N/A	N/A	DWS Provided?	N/A
		N/A	Landing Width (in)	N/A	N/A	DWS Contrast?	N/A
		N/A	Landing Slope (%)	N/A	N/A	DWS Length (in)	N/A
		N/A	Landing X Slope (%)	N/A	N/A	DWS Full Width?	N/A
	PROW/ADA:  <b>R304.5.3</b>	N/A	Landing Curb? (Y/N)	N/A	N/A	DWS Offset (in)	N/A
		N/A	Shared Landing?	N/A			
		N/A	Gutter Ponding?	N/A	N/A	Gutter Slope (%)	N/A
		N/A	Gutter Lip Ht (in)	N/A	N/A	Gutter X Slope (%)	N/A
		N/A	Painted X Walk1?	Yes	N/A	Painted X Walk2?	N/A
			X Walk 1 Direction	To N		X Walk 2 Direction	N/A

N/A	X Walk 1 Width (in)	33.5	N/A	X Walk 2 Width (in)	N/A
			X Walk 1 Slope (%)	3.5		X Walk 2 Slope (%)	N/A
			X Walk 1 X Slope (%)	3.9		X Walk 2 X Slope (%)	N/A
		N/A	Ramp inside XWalk1?	Yes	N/A	Ramp inside XWalk2?	N/A
Street 1 Name	KENDALL DR		Road Slope (%)	2.2	N/A	Clear Space?	N/A
Stop Condition-Street 2	StopSign		Road X Slope (%)	3.5	N/A	Clear Space to XWalk (in)	N/A
Street 2 Name	N/A		Any Obstructions?	N/A	N/A	Storm Grate/Utility Hazard?	N/A
Stop Condition-Street 1	N/A		Obstruction Type			Storm Grate/Utility Type	
Total Cost:		\$	1850.00		N/A		N/A
					Yes	Surface Condition? (G/P)	Good
