# Access Compliance Report

## Public Rights-of-Way

### (Curb Ramps)

Intersection ID: 21016	Main Street: COVEDALE_DR	Cross Street: WISHING_WELL_LN	Location: SW
ADA ID: B04AE85ABD55	Ramp Type: PerpDiag	Initial Pass/Fail: Fail	Overall Compliance: No
Severity Score: 1.25			
Codes/Mitigation Info/Possible Solution		Field Measurements/Component Compliance

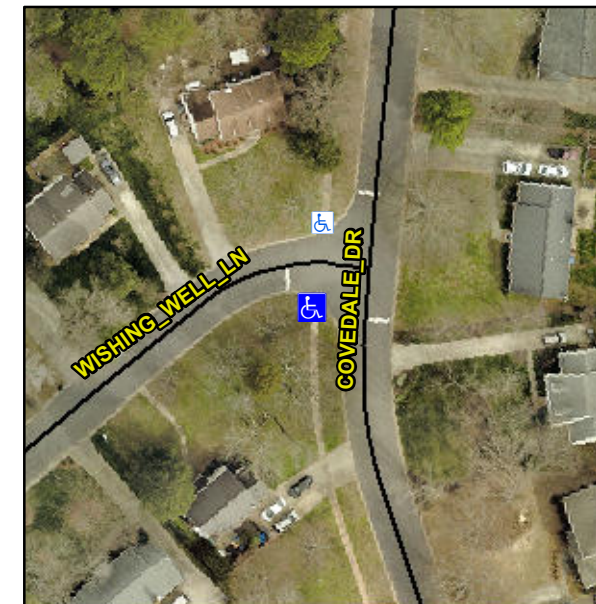
**Not Found, R304.5.3**

Compliance	Description	Data	Compliance	Description	Data
N/A	Ramp Length (in)	30.0	Yes	Ramp Slope (%)	6.3
Yes	Ramp Width (in)	48.0	No	Ramp XSlope (%)	4.3
N/A	Flare Type LT	N/A	N/A	Flare Type RT	N/A
N/A	Flare Slope LT (%)	N/A	N/A	Flare Slope RT (%)	N/A
N/A	Flare Traversable LT?	N/A	N/A	Flare Traversable RT?	N/A
N/A	Landing Length (in)	N/A	N/A	DWS Provided?	N/A
N/A	Landing Width (in)	N/A	N/A	DWS Contrast?	N/A
N/A	Landing Slope (%)	N/A	N/A	DWS Length (in)	N/A
N/A	Landing X Slope (%)	N/A	N/A	DWS Full Width?	N/A
N/A	Landing Curb? (Y/N)	N/A	N/A	DWS Offset (in)	N/A
N/A	Shared Landing?	N/A			
N/A	Gutter Ponding?	N/A	N/A	Gutter Slope (%)	N/A
N/A	Gutter Lip Ht (in)	N/A	N/A	Gutter X Slope (%)	N/A
N/A	Painted X Walk1?	No	N/A	Painted X Walk2?	No
	X Walk 1 Direction	To SE		X Walk 2 Direction	To NE
N/A	X Walk 1 Width (in)	N/A	N/A	X Walk 2 Width (in)	N/A
	X Walk 1 Slope (%)	7.0		X Walk 2 Slope (%)	1.5
	X Walk 1 X Slope (%)	1.9		X Walk 2 X Slope (%)	6.6

N/A	Ramp inside XWalk1?	N/A	N/A	Ramp inside XWalk2?	N/A
	Road Slope (%)	4.8	N/A	Clear Space?	N/A
	Road X Slope (%)	7.1	N/A	Clear Space to XWalk (in)	N/A
N/A	Any Obstructions?	N/A	N/A	Storm Grate/Utility Hazard?	N/A
	Obstruction Type			Storm Grate/Utility Type	
		N/A			N/A
		Yes		Surface Condition? (G/P)	Good

**Remove & Replace Curb Ramp With Two New Directional Ramps or Equivalent.**

Total Cost: \$ 3200.00
