Access Compliance Report

Public Rights-of-Way

(Curb Ramps)

Intersection ID: 52926	Main Street: WALTHAM_LN	Cross Street: EMORY_OAK_DR	Location: SW
ADA ID: B04DE2F56921	Ramp Type: Perp	Initial Pass/Fail: Pass	Overall Compliance: No
Codes/Mitigation Info/Possible Solution		Field Measurements/Component Compliance	
Severity Score: 10.25

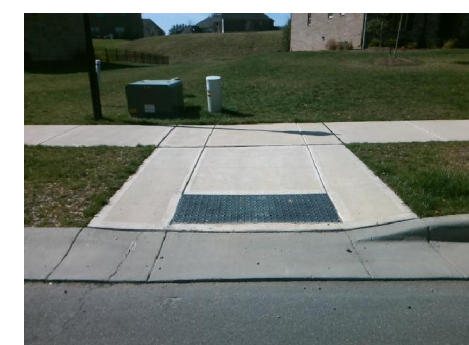
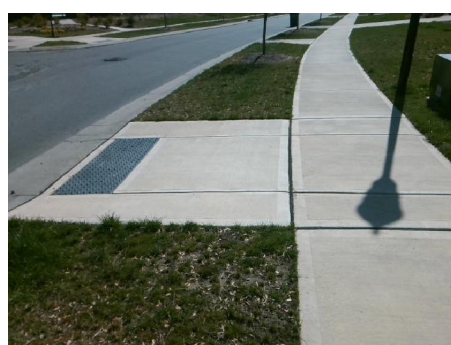
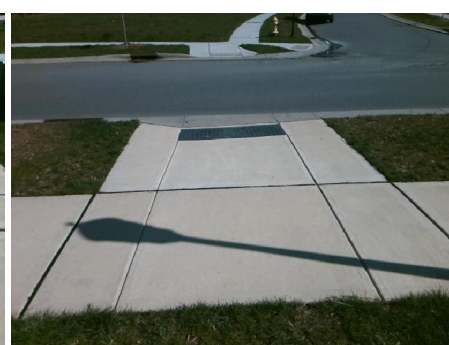
Compliance	Description	Data	Compliance	Description	Data
N/A	Ramp Length (in)	95.5	Yes	Ramp Slope (%)	6.2
Yes	Ramp Width (in)	60.0	No	Ramp XSlope (%)	2.2
N/A	Flare Type LT	Sloped	N/A	Flare Type RT	N/A
N/A	Flare Slope LT (%)	3.7	No	Flare Slope RT (%)	18.3
N/A	Flare Traversable LT?	Yes	N/A	Flare Traversable RT?	Yes
Yes	Landing Length (in)	61.0	Yes	DWS Provided?	Yes
Yes	Landing Width (in)	60.0	Yes	DWS Contrast?	Yes
Yes	Landing Slope (%)	1.6	Yes	DWS Length (in)	24.0
No	Landing X Slope (%)	2.1	Yes	DWS Full Width?	Yes
N/A	Landing Curb? (Y/N)	No	No	DWS Offset (in)	5.5
N/A	Shared Landing?	No			
Yes	Gutter Ponding?	No	No	Gutter Slope (%)	8.1
Yes	Gutter Lip Ht (in)	0.0	No	Gutter X Slope (%)	2.3
N/A	Painted X Walk1?	No	N/A	Painted X Walk2?	N/A
	X Walk 1 Direction	To N		X Walk 2 Direction	N/A
N/A	X Walk 1 Width (in)	N/A	N/A	X Walk 2 Width (in)	N/A
	X Walk 1 Slope (%)	2.6		X Walk 2 Slope (%)	N/A
	X Walk 1 X Slope (%)	1.6		X Walk 2 X Slope (%)	N/A

N/A	Ramp inside XWalk1?	N/A	N/A	Ramp inside XWalk2?	N/A
	Road Slope (%)	N/A	N/A	Clear Space?	Yes
	Road X Slope (%)	N/A	N/A	Clear Space to XWalk (in)	N/A
Yes	Any Obstructions?	No	Yes	Storm Grate/Utility Hazard?	No
	Obstruction Type			Storm Grate/Utility Type	
		N/A			N/A
			Yes	Surface Condition? (G/P)	Good

Possible Solutions:

**Remove & Replace Entire Ramp.
Remove & Replace Gutter.**
