Access Compliance Report Public Rights-of-Way (Curb Ramps)

Intersection ID: 47644 Main Street: DESHLER_MORRIS_LN Cross Street: WESTON_WOODS_LN Location: SE

ADA ID: B0552AC1510B Ramp Type: PerpDiag Initial Pass/Fail: Fail Overall Compliance: No Severity Score: 25

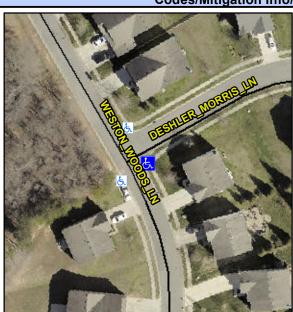
Field Measurements/Component Compliance						
Compliance Description		Data	Com	oliance Description	Data	
N	I/A	Ramp Length (in)	47.0	No	Ramp Slope (%)	11.0
Υ	es	Ramp Width (in)	48.0	No	Ramp XSlope (%)	5.2
N	/ A	Flare Type LT	N/A	N/A	Flare Type RT	N/A
N	l/A	Flare Slope LT (%)	N/A	N/A	Flare Slope RT (%)	N/A
N	I/A	Flare Traversable LT?	N/A	N/A	Flare Traversable RT?	N/A
N	l/A	Landing Length (in)	N/A	N/A	DWS Provided?	N/A
N	l/A	Landing Width (in)	N/A	N/A	DWS Contrast?	N/A
N	l/A	Landing Slope (%)	N/A	N/A	DWS Length (in)	N/A
N	I/A	Landing X Slope (%)	N/A	N/A	DWS Full Width?	N/A
N	I/A	Landing Curb? (Y/N)	N/A	N/A	DWS Offset (in)	N/A
N	I/A	Shared Landing?	N/A			
N	I/A	Gutter Ponding?	N/A	N/A	Gutter Slope (%)	N/A
N	/ A	Gutter Lip Ht (in)	N/A	N/A	Gutter X Slope (%)	N/A
N	I/A	Painted X Walk1?	No	N/A	Painted X Walk2?	No
		X Walk 1 Direction	To NW		X Walk 2 Direction	To SW
N	I/A	X Walk 1 Width (in)	N/A	N/A	X Walk 2 Width (in)	N/A

X Walk 1 Slope (%)	0.3		X Walk 2 Slope (%)	0.9
		X Walk 1 X Slope (%)	3.3		X Walk 2 X Slope (%)	1.2
N	I/A	Ramp inside XWalk1?	N/A	N/A	Ramp inside XWalk2?	N/A
		Road Slope (%)	3.4	N/A	Clear Space?	N/A
		Road X Slope (%)	1.3	N/A	Clear Space to XWalk (in)	N/A
N	I/A	Any Obstructions?	N/A	N/A	Storm Grate/Utility Hazard?	N/A
		Obstruction Type			Storm Grate/Utility Type	
			N/A			N/A
				Yes	Surface Condition? (G/P)	Good

Remove & Replace Curb Ramp With Two New Directional Ramps or Equivalent.

Not Found, R304.2.2, R304.5.3
