Access Compliance Report Public Rights-of-Way (Curb Ramps)

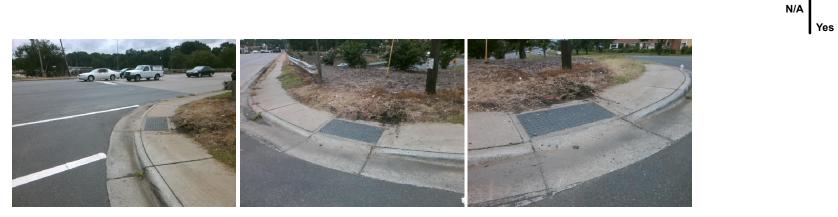
· · · · · · · · · · · · · · · · · · ·			,					
Intersection ID: 7185 Main Street: S_I-85_EXIT_41_RA					reet:	W_SUGAR_CREEK_	Location:	SW		
ADA ID: B058EC4A7FB4	A7FB4 Ramp Type: PerpDiag			nitial Pa	ss/Fa	ail: Pass Overall	o Severity Score:	0		
Codes/Mitigation Info/Possible Solution					Field Measurements/Component Compliance					
		Possible Solutions:			Compliance Description		Data Complia		ance Description	Data
		Remove & Replace Curb Ra	mp Wit	h	N/A	Ramp Length (in)	30.5	Yes	Ramp Slope (%)	7.7
		Two New Directional Ramps	•		Yes	Ramp Width (in)	54.5	Yes	Ramp XSlope (%)	0.5
Er Contract		Equivalent.		I	N/A	Flare Type LT	Sloped	N/A	Flare Type RT	N/A
Le la					N/A	Flare Slope LT (%)	8.7	Yes	Flare Slope RT (%)	7.2
		Surveyor Notes:			N/A	Flare Traversable LT?	Yes	N/A	Flare Traversable RT?	Yes
a and					No	Landing Length (in)	19.5	Yes	DWS Provided?	Yes
a leise					Yes	Landing Width (in)	54.0	Yes	DWS Contrast?	Yes

the second secon		N/A			No	Landing Slope (%)	3.4	Yes	DWS Length (in)	24.0
SIM STATES					Yes	Landing X Slope (%)	0.7	Yes	DWS Full Width?	Yes
1 1 Barris and					N/A	Landing Curb? (Y/N)	No	No	DWS Offset (in)	4.0
					N/A	Shared Landing?	No			
		PROW/ADA:			No	Gutter Ponding?	Yes	Yes	Gutter Slope (%)	2.4
	1 1 1 /	Not Found, R304.2.1, R304.2). `	Yes	Gutter Lip Ht (in)	0.0	Yes	Gutter X Slope (%)	0.9	
and the second	ALE LIN	R304.3.2-Para, R305.2, R302	•	•	N/A	Painted X Walk1?	No	N/A	Painted X Walk2?	Yes
	34					X Walk 1 Direction	To E		X Walk 2 Direction	To N
					N/A	X Walk 1 Width (in)	N/A	N/A	X Walk 2 Width (in)	113.5
Street 1 Name	W SUGAR CREEK RD	-				X Walk 1 Slope (%)	0.3		X Walk 2 Slope (%)	2.5
Stop Condition-Street 2	Signal					X Walk 1 X Slope (%)	0.6		X Walk 2 X Slope (%)	0.8
Street 2 Name	S I-85 EXIT 41 RA				N/A	Ramp inside XWalk1?	N/A	Yes	Ramp inside XWalk2?	Yes
Stop Condition-Street 1	Signal					Road Slope (%)	3.2	N/A	Clear Space?	Yes

Road X Slope (%)	0.2	N/A	Clear Space to XWalk (in)	N/A
					Yes	Any Obstructions?	No	Yes	Storm Grate/Utility Hazard?	No
		Total Cost:	\$ 320	0.00		Obstruction Type			Storm Grate/Utility Type	
							N/A			N/A
1

es Surface Condition? (G/P) Good
