Access Compliance Report

Public Rights-of-Way (Curb Ramps)

Intersection ID: 42916	Main Street: CROSSWALK_DR	Cross Street: HIGHFIELD_CT	Location:	W
ADA ID: B05BD9C8963E	Ramp Type: Combination1Diag	Initial Pass/Fail: Fail	Overall Compliance: No	Severity Score: 0
Codes/Mitigation Info/Possible Solution		Field Measurements/Component Compliance

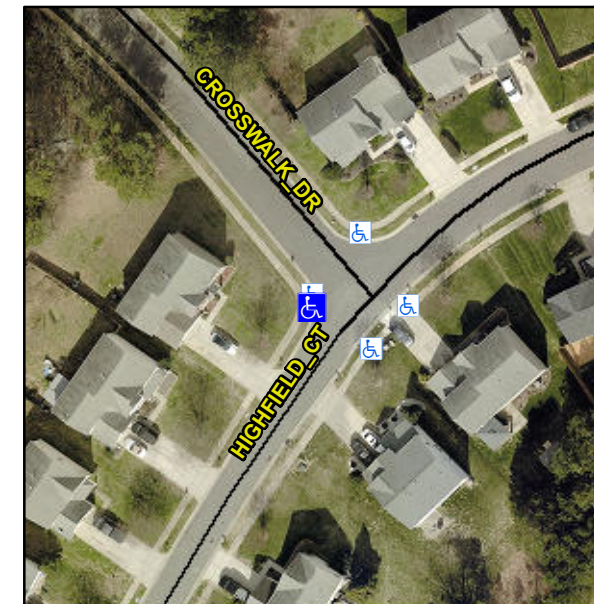
RP SL < 5%

Not Found, R304.5.1, R304.5.3, R304.3.2

Compliance	Description	Data	Compliance	Description	Data
N/A	Ramp Length LT (in)	40.5	N/A	Ramp Length RT (in)	45.5
Yes	Ramp Width LT (in)	48.0	Yes	Ramp Width RT (in)	48.0
No	Ramp Slope LT (%)	9.4	No	Ramp Slope RT (%)	8.6
No	Ramp XSlope LT (%)	2.5	No	Ramp XSlope RT (%)	2.1
N/A	Ramp Length (in)	47.5	Yes	Ramp Slope (%)	3.8
No	Ramp Width (in)	44.5	No	Ramp XSlope (%)	8.0
N/A	Flare Type LT	N/A	N/A	Flare Type RT	N/A
N/A	Flare Slope LT (%)	N/A	N/A	Flare Slope RT (%)	N/A
N/A	Flare Traversable LT?	N/A	N/A	Flare Traversable RT?	N/A
N/A	Landing Length (in)	N/A	N/A	DWS Provided?	N/A
N/A	Landing Width (in)	N/A	N/A	DWS Contrast?	N/A
N/A	Landing Slope (%)	N/A	N/A	DWS Length (in)	N/A
N/A	Landing X Slope (%)	N/A	N/A	DWS Full Width?	N/A
N/A	Landing Curb? (Y/N)	N/A	N/A	DWS Offset (in)	N/A
N/A	Shared Landing?	N/A			
N/A	Gutter Ponding?	N/A	N/A	Gutter Slope (%)	N/A
N/A	Gutter Lip Ht (in)	N/A	N/A	Gutter X Slope (%)	N/A
N/A	Painted X Walk1?	No	N/A	Painted X Walk2?	No

X Walk 1 Direction	To SE		X Walk 2 Direction	To NE
	X Walk 1 Width (in)	N/A		X Walk 2 Width (in)	N/A
	X Walk 1 Slope (%)	3.7		X Walk 2 Slope (%)	0.8
	X Walk 1 X Slope (%)	4.6		X Walk 2 X Slope (%)	6.3
N/A	Ramp inside XWalk1?	N/A	N/A	Ramp inside XWalk2?	N/A
	Road Slope (%)	5.3		Clear Space?	N/A
	Road X Slope (%)	3.9	N/A	Clear Space to XWalk (in)	N/A
			N/A	Any Obstruction?	N/A
				Obstruction Type	N/A
			N/A	Storm Grate/Utility Hazard?	N/A
				Storm Grate/Utility Type	N/A
Yes	Surface Condition? (G/P)	Good			
	Curb Slope (%)	12.3

Remove & Replace Curb Ramp With Two New Directional Ramps or Equivalent.
