Access Compliance Report

Public Rights-of-Way

(Curb Ramps)

Intersection ID: 18848	Main Street: TYVOLA_RD	Cross Street: TYVOLA_RD	Location: SW
ADA ID: B05D45372D01	Ramp Type: Perp	Initial Pass/Fail: Fail	Overall Compliance: No
		Severity Score: 37.5

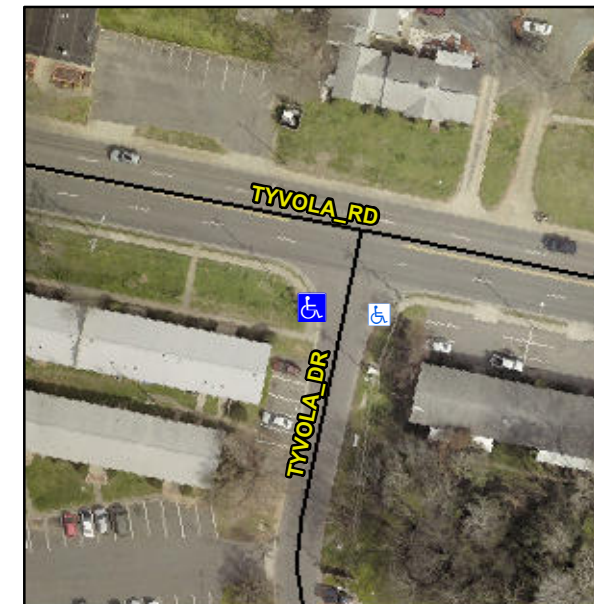
Not Found, R304.2.2, R304.5.3

Compliance	Description	Data	Compliance	Description	Data
N/A	Ramp Length (in)	57.5	No	Ramp Slope (%)	10.6
Yes	Ramp Width (in)	48.0	No	Ramp XSlope (%)	7.4
N/A	Flare Type LT	N/A	N/A	Flare Type RT	N/A
N/A	Flare Slope LT (%)	N/A	N/A	Flare Slope RT (%)	N/A
N/A	Flare Traversable LT?	N/A	N/A	Flare Traversable RT?	N/A
N/A	Landing Length (in)	N/A	N/A	DWS Provided?	N/A
N/A	Landing Width (in)	N/A	N/A	DWS Contrast?	N/A
N/A	Landing Slope (%)	N/A	N/A	DWS Length (in)	N/A
N/A	Landing X Slope (%)	N/A	N/A	DWS Full Width?	N/A
N/A	Landing Curb? (Y/N)	N/A	N/A	DWS Offset (in)	N/A
N/A	Shared Landing?	N/A			
N/A	Gutter Ponding?	N/A	N/A	Gutter Slope (%)	N/A
N/A	Gutter Lip Ht (in)	N/A	N/A	Gutter X Slope (%)	N/A
N/A	Painted X Walk1?	No	N/A	Painted X Walk2?	N/A
	X Walk 1 Direction	To SE		X Walk 2 Direction	N/A
N/A	X Walk 1 Width (in)	N/A	N/A	X Walk 2 Width (in)	N/A
	X Walk 1 Slope (%)	0.6		X Walk 2 Slope (%)	N/A
	X Walk 1 X Slope (%)	5.6		X Walk 2 X Slope (%)	N/A

N/A	Ramp inside XWalk1?	N/A	N/A	Ramp inside XWalk2?	N/A
	Road Slope (%)	N/A	N/A	Clear Space?	N/A
	Road X Slope (%)	N/A	N/A	Clear Space to XWalk (in)	N/A
N/A	Any Obstructions?	N/A	N/A	Storm Grate/Utility Hazard?	N/A
	Obstruction Type			Storm Grate/Utility Type	
		N/A			N/A
			Yes	Surface Condition? (G/P)	Good

Remove & Replace Entire Ramp.
