Access Compliance Report

Public Rights-of-Way

(Curb Ramps)

Intersection ID: 6085	Main Street: HARTLEY_HILLS_DR	Cross Street: WYNDHAM_POINTE_DR	Location:	N
ADA ID: B05D865C1849	Ramp Type: Perp	Initial Pass/Fail: Fail	Overall Compliance: No	Severity Score: 25
Codes/Mitigation Info/Possible Solution		Field Measurements/Component Compliance

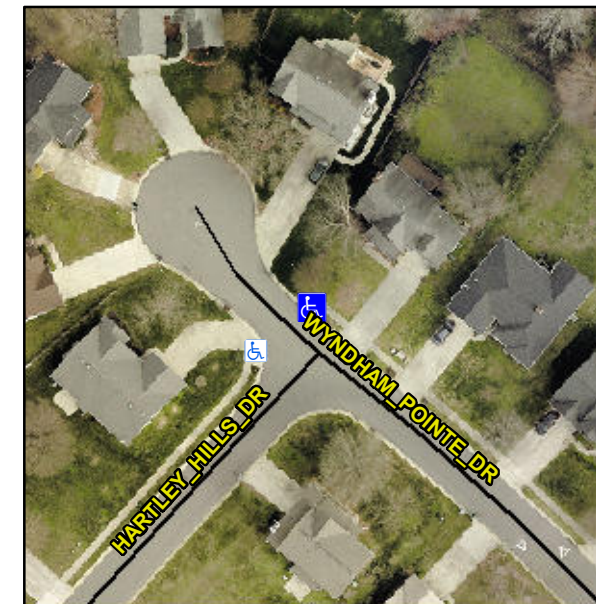
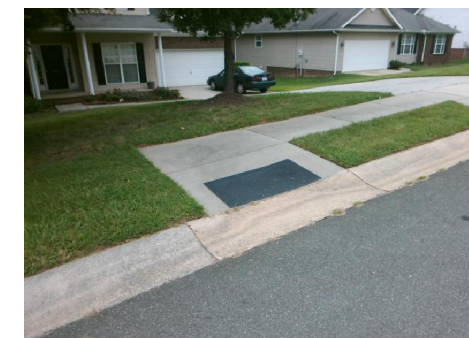
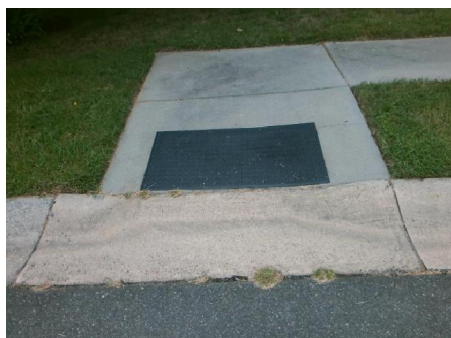
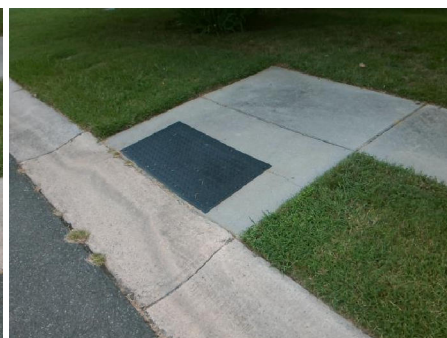
Not Found, R304.2.2, R304.5.3

Compliance	Description	Data	Compliance	Description	Data
N/A	Ramp Length (in)	45.0	No	Ramp Slope (%)	9.6
Yes	Ramp Width (in)	48.0	No	Ramp XSlope (%)	5.5
N/A	Flare Type LT	N/A	N/A	Flare Type RT	N/A
N/A	Flare Slope LT (%)	N/A	N/A	Flare Slope RT (%)	N/A
N/A	Flare Traversable LT?	N/A	N/A	Flare Traversable RT?	N/A
N/A	Landing Length (in)	N/A	N/A	DWS Provided?	N/A
N/A	Landing Width (in)	N/A	N/A	DWS Contrast?	N/A
N/A	Landing Slope (%)	N/A	N/A	DWS Length (in)	N/A
N/A	Landing X Slope (%)	N/A	N/A	DWS Full Width?	N/A
N/A	Landing Curb? (Y/N)	N/A	N/A	DWS Offset (in)	N/A
N/A	Shared Landing?	N/A			
N/A	Gutter Ponding?	N/A	N/A	Gutter Slope (%)	N/A
N/A	Gutter Lip Ht (in)	N/A	N/A	Gutter X Slope (%)	N/A
N/A	Painted X Walk1?	No	N/A	Painted X Walk2?	N/A
	X Walk 1 Direction	To SW		X Walk 2 Direction	N/A
N/A	X Walk 1 Width (in)	N/A	N/A	X Walk 2 Width (in)	N/A
	X Walk 1 Slope (%)	4.1		X Walk 2 Slope (%)	N/A
	X Walk 1 X Slope (%)	5.0		X Walk 2 X Slope (%)	N/A

N/A	Ramp inside XWalk1?	N/A	N/A	Ramp inside XWalk2?	N/A
	Road Slope (%)	N/A	N/A	Clear Space?	N/A
	Road X Slope (%)	N/A	N/A	Clear Space to XWalk (in)	N/A
N/A	Any Obstructions?	N/A	N/A	Storm Grate/Utility Hazard?	N/A
	Obstruction Type			Storm Grate/Utility Type	
		N/A			N/A
			Yes	Surface Condition? (G/P)	Good

Possible Solutions:

Remove & Replace Entire Ramp.

Total Cost: \$ 1850.00
