# Access Compliance Report

## Public Rights-of-Way

### (Curb Ramps)

Intersection ID: 9892	Main Street: N_TURNER_AV	Cross Street: W_TRADE_ST	Location: S
ADA ID: B05ED5699CCF	Ramp Type: Perp	Initial Pass/Fail: Fail	Overall Compliance: No
		Severity Score: 22.5	
Codes/Mitigation Info/Possible Solution		Field Measurements/Component Compliance

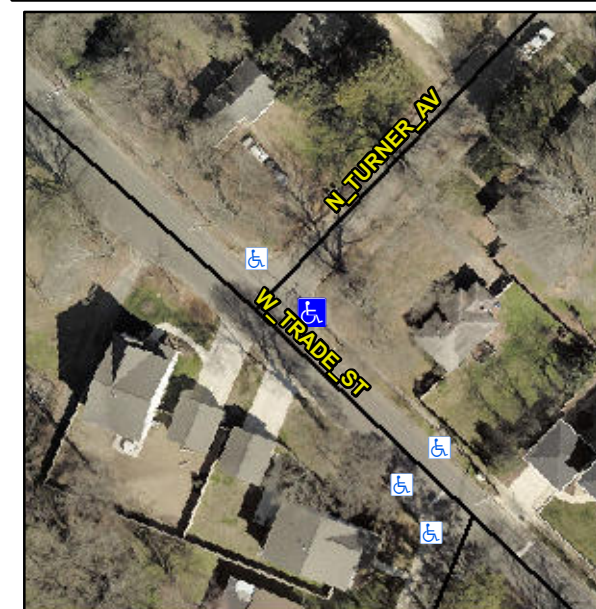
**Not Found, R304.5.1, R304.2.2, R304.5.3**

Compliance	Description	Data	Compliance	Description	Data
N/A	Ramp Length (in)	49.0	No	Ramp Slope (%)	11.0
No	Ramp Width (in)	47.5	No	Ramp XSlope (%)	4.7
N/A	Flare Type LT	N/A	N/A	Flare Type RT	N/A
N/A	Flare Slope LT (%)	N/A	N/A	Flare Slope RT (%)	N/A
N/A	Flare Traversable LT?	N/A	N/A	Flare Traversable RT?	N/A
N/A	Landing Length (in)	N/A	N/A	DWS Provided?	N/A
N/A	Landing Width (in)	N/A	N/A	DWS Contrast?	N/A
N/A	Landing Slope (%)	N/A	N/A	DWS Length (in)	N/A
N/A	Landing X Slope (%)	N/A	N/A	DWS Full Width?	N/A
N/A	Landing Curb? (Y/N)	N/A	N/A	DWS Offset (in)	N/A
N/A	Shared Landing?	N/A			
N/A	Gutter Ponding?	N/A	N/A	Gutter Slope (%)	N/A
N/A	Gutter Lip Ht (in)	0.5	N/A	Gutter X Slope (%)	N/A
N/A	Painted X Walk1?	No	N/A	Painted X Walk2?	N/A
	X Walk 1 Direction	To N		X Walk 2 Direction	N/A
N/A	X Walk 1 Width (in)	N/A	N/A	X Walk 2 Width (in)	N/A
	X Walk 1 Slope (%)	2.7		X Walk 2 Slope (%)	N/A
	X Walk 1 X Slope (%)	3.1		X Walk 2 X Slope (%)	N/A

N/A	Ramp inside XWalk1?	N/A	N/A	Ramp inside XWalk2?	N/A
	Road Slope (%)	N/A	N/A	Clear Space?	N/A
	Road X Slope (%)	N/A	N/A	Clear Space to XWalk (in)	N/A
N/A	Any Obstructions?	N/A	N/A	Storm Grate/Utility Hazard?	N/A
	Obstruction Type			Storm Grate/Utility Type	
		N/A			N/A
			Yes	Surface Condition? (G/P)	Good

**Remove & Replace Entire Ramp.**

Total Cost: \$ 1850.00
