# Access Compliance Report

## Public Rights-of-Way

### (Curb Ramps)

Intersection ID: N/A	Main Street: SOUTH_BV	Cross Street: N/A	Location: E
ADA ID: B06A1E6B3291	Ramp Type: Perp	Initial Pass/Fail: Fail	Overall Compliance: No
Severity Score: 12.5			
Codes/Mitigation Info/Possible Solution		Field Measurements/Component Compliance

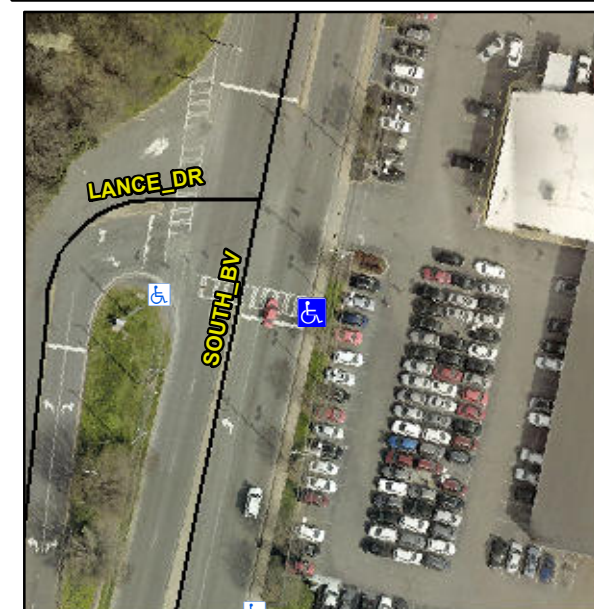
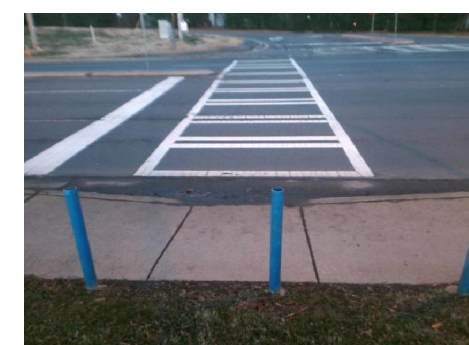
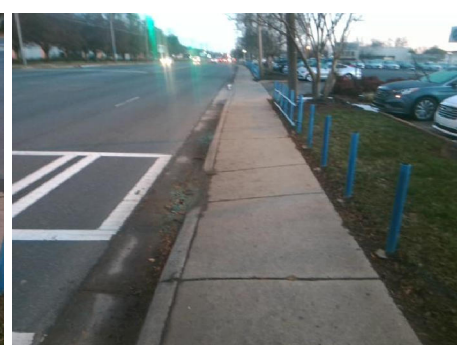
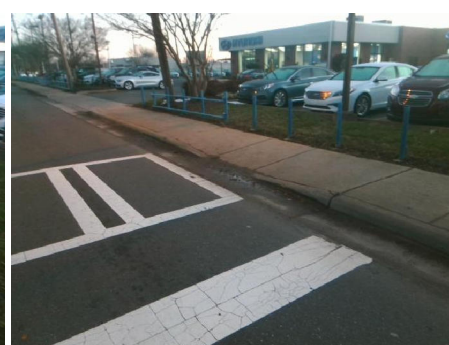
**Not Found, R304.2.2**

Compliance	Description	Data	Compliance	Description	Data
N/A	Ramp Length (in)	59.0	No	Ramp Slope (%)	11.4
Yes	Ramp Width (in)	48.0	Yes	Ramp XSlope (%)	0.5
N/A	Flare Type LT	N/A	N/A	Flare Type RT	N/A
N/A	Flare Slope LT (%)	N/A	N/A	Flare Slope RT (%)	N/A
N/A	Flare Traversable LT?	N/A	N/A	Flare Traversable RT?	N/A
N/A	Landing Length (in)	N/A	N/A	DWS Provided?	N/A
N/A	Landing Width (in)	N/A	N/A	DWS Contrast?	N/A
N/A	Landing Slope (%)	N/A	N/A	DWS Length (in)	N/A
N/A	Landing X Slope (%)	N/A	N/A	DWS Full Width?	N/A
N/A	Landing Curb? (Y/N)	N/A	N/A	DWS Offset (in)	N/A
N/A	Shared Landing?	N/A			
N/A	Gutter Ponding?	N/A	N/A	Gutter Slope (%)	N/A
N/A	Gutter Lip Ht (in)	N/A	N/A	Gutter X Slope (%)	N/A
N/A	Painted X Walk1?	Yes	N/A	Painted X Walk2?	N/A
	X Walk 1 Direction	To W		X Walk 2 Direction	N/A
N/A	X Walk 1 Width (in)	114.0	N/A	X Walk 2 Width (in)	N/A
	X Walk 1 Slope (%)	0.2		X Walk 2 Slope (%)	N/A
	X Walk 1 X Slope (%)	0.0		X Walk 2 X Slope (%)	N/A

N/A	Ramp inside XWalk1?	Yes	N/A	Ramp inside XWalk2?	N/A
	Road Slope (%)	N/A	N/A	Clear Space?	N/A
	Road X Slope (%)	N/A	N/A	Clear Space to XWalk (in)	N/A
N/A	Any Obstructions?	N/A	N/A	Storm Grate/Utility Hazard?	N/A
	Obstruction Type			Storm Grate/Utility Type	
		N/A			N/A
		Yes		Surface Condition? (G/P)	Good

**Remove & Replace Entire Ramp.**
