Access Compliance Report

Public Rights-of-Way

(Curb Ramps)

Intersection ID: 18391	Main Street: LYNBROOK_DR	Cross Street: RAMA_RD	Location: SE
ADA ID: B06A80574D83	Ramp Type: PerpDiag	Initial Pass/Fail: Fail	Overall Compliance: No
Codes/Mitigation Info/Possible Solution		Field Measurements/Component Compliance	
Severity Score: 13.75

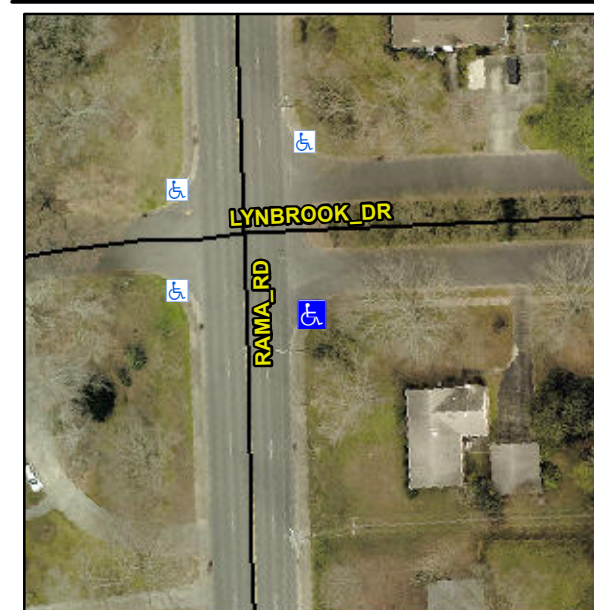
Not Found, R304.2.2, R304.5.3

Compliance	Description	Data	Compliance	Description	Data
N/A	Ramp Length (in)	59.5	No	Ramp Slope (%)	9.9
Yes	Ramp Width (in)	48.0	No	Ramp XSlope (%)	2.3
N/A	Flare Type LT	N/A	N/A	Flare Type RT	N/A
N/A	Flare Slope LT (%)	N/A	N/A	Flare Slope RT (%)	N/A
N/A	Flare Traversable LT?	N/A	N/A	Flare Traversable RT?	N/A
N/A	Landing Length (in)	N/A	N/A	DWS Provided?	N/A
N/A	Landing Width (in)	N/A	N/A	DWS Contrast?	N/A
N/A	Landing Slope (%)	N/A	N/A	DWS Length (in)	N/A
N/A	Landing X Slope (%)	N/A	N/A	DWS Full Width?	N/A
N/A	Landing Curb? (Y/N)	N/A	N/A	DWS Offset (in)	N/A
N/A	Shared Landing?	N/A			
N/A	Gutter Ponding?	N/A	N/A	Gutter Slope (%)	N/A
N/A	Gutter Lip Ht (in)	N/A	N/A	Gutter X Slope (%)	N/A
N/A	Painted X Walk1?	No	N/A	Painted X Walk2?	No
	X Walk 1 Direction	To NE		X Walk 2 Direction	To NW
N/A	X Walk 1 Width (in)	N/A	N/A	X Walk 2 Width (in)	N/A
	X Walk 1 Slope (%)	1.8		X Walk 2 Slope (%)	0.2
	X Walk 1 X Slope (%)	0.3		X Walk 2 X Slope (%)	1.7

N/A	Ramp inside XWalk1?	N/A	N/A	Ramp inside XWalk2?	N/A
	Road Slope (%)	1.4	N/A	Clear Space?	N/A
	Road X Slope (%)	2.3	N/A	Clear Space to XWalk (in)	N/A
N/A	Any Obstructions?	N/A	N/A	Storm Grate/Utility Hazard?	N/A
	Obstruction Type			Storm Grate/Utility Type	
		N/A			N/A
		Yes		Surface Condition? (G/P)	Good

Remove & Replace Curb Ramp With Two New Directional Ramps or Equivalent.

Total Cost: \$ 3200.00
