Access Compliance Report

Public Rights-of-Way

(Curb Ramps)

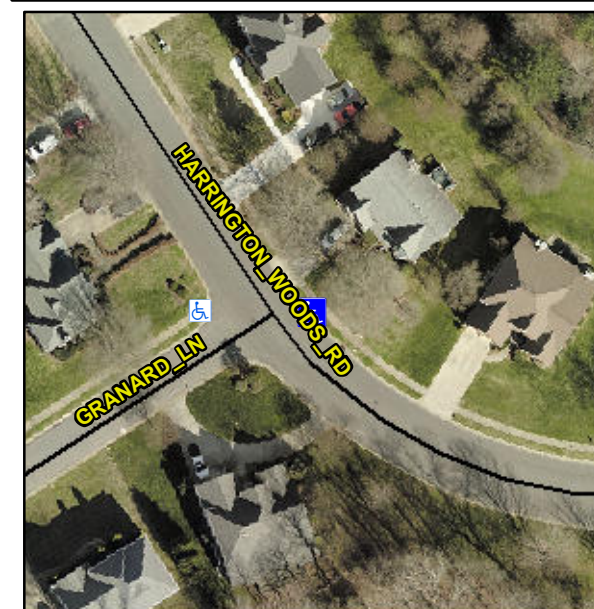
Intersection ID: 4877	Main Street: GRANARD_LN	Cross Street: HARRINGTON_WOODS_RD	Location: SE
ADA ID: B06D30768E16	Ramp Type: Perp	Initial Pass/Fail: Fail	Overall Compliance: No
Codes/Mitigation Info/Possible Solution			Severity Score: 25
			Field Measurements/Component Compliance

Not Found, R304.5.3

Compliance	Description	Data	Compliance	Description	Data
N/A	Ramp Length (in)	48.0	Yes	Ramp Slope (%)	7.3
Yes	Ramp Width (in)	48.0	No	Ramp XSlope (%)	8.5
N/A	Flare Type LT	N/A	N/A	Flare Type RT	N/A
N/A	Flare Slope LT (%)	N/A	N/A	Flare Slope RT (%)	N/A
N/A	Flare Traversable LT?	N/A	N/A	Flare Traversable RT?	N/A
N/A	Landing Length (in)	N/A	N/A	DWS Provided?	N/A
N/A	Landing Width (in)	N/A	N/A	DWS Contrast?	N/A
N/A	Landing Slope (%)	N/A	N/A	DWS Length (in)	N/A
N/A	Landing X Slope (%)	N/A	N/A	DWS Full Width?	N/A
N/A	Landing Curb? (Y/N)	N/A	N/A	DWS Offset (in)	N/A
N/A	Shared Landing?	N/A			
N/A	Gutter Ponding?	N/A	N/A	Gutter Slope (%)	N/A
N/A	Gutter Lip Ht (in)	N/A	N/A	Gutter X Slope (%)	N/A
N/A	Painted X Walk1?	No	N/A	Painted X Walk2?	N/A
	X Walk 1 Direction	To NW		X Walk 2 Direction	N/A
N/A	X Walk 1 Width (in)	N/A	N/A	X Walk 2 Width (in)	N/A
	X Walk 1 Slope (%)	3.8		X Walk 2 Slope (%)	N/A
	X Walk 1 X Slope (%)	7.6		X Walk 2 X Slope (%)	N/A

N/A	Ramp inside XWalk1?	N/A	N/A	Ramp inside XWalk2?	N/A
	Road Slope (%)	N/A	N/A	Clear Space?	N/A
	Road X Slope (%)	N/A	N/A	Clear Space to XWalk (in)	N/A
N/A	Any Obstructions?	N/A	N/A	Storm Grate/Utility Hazard?	N/A
	Obstruction Type			Storm Grate/Utility Type	
		N/A			N/A
			Yes	Surface Condition? (G/P)	Good

Possible Solutions:

Remove & Replace Entire Ramp.

Total Cost: \$ 1850.00
