Access Compliance Report

Public Rights-of-Way

(Curb Ramps)

Intersection ID: 45180	Main Street: SOCIETY_ST	Cross Street: TORRELLE_DR	Location: NE
ADA ID: B07B4670C4AF	Ramp Type: PerpDiag	Initial Pass/Fail: Fail	Overall Compliance: No
Codes/Mitigation Info/Possible Solution		Field Measurements/Component Compliance

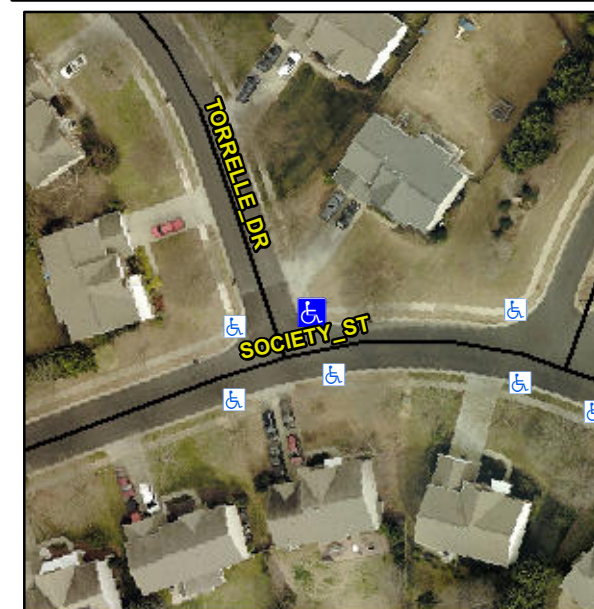
Not Found, R304.5.1, R304.5.3

Compliance	Description	Data	Compliance	Description	Data
N/A	Ramp Length (in)	92.0	Yes	Ramp Slope (%)	5.2
No	Ramp Width (in)	47.5	No	Ramp XSlope (%)	5.2
N/A	Flare Type LT	N/A	N/A	Flare Type RT	N/A
N/A	Flare Slope LT (%)	N/A	N/A	Flare Slope RT (%)	N/A
N/A	Flare Traversable LT?	N/A	N/A	Flare Traversable RT?	N/A
N/A	Landing Length (in)	N/A	N/A	DWS Provided?	N/A
N/A	Landing Width (in)	N/A	N/A	DWS Contrast?	N/A
N/A	Landing Slope (%)	N/A	N/A	DWS Length (in)	N/A
N/A	Landing X Slope (%)	N/A	N/A	DWS Full Width?	N/A
N/A	Landing Curb? (Y/N)	N/A	N/A	DWS Offset (in)	N/A
N/A	Shared Landing?	N/A			
N/A	Gutter Ponding?	N/A	N/A	Gutter Slope (%)	N/A
N/A	Gutter Lip Ht (in)	N/A	N/A	Gutter X Slope (%)	N/A
N/A	Painted X Walk1?	No	N/A	Painted X Walk2?	No
	X Walk 1 Direction	To W		X Walk 2 Direction	To S
N/A	X Walk 1 Width (in)	N/A	N/A	X Walk 2 Width (in)	N/A
	X Walk 1 Slope (%)	0.5		X Walk 2 Slope (%)	0.9
	X Walk 1 X Slope (%)	0.9		X Walk 2 X Slope (%)	0.8

N/A	Ramp inside XWalk1?	N/A	N/A	Ramp inside XWalk2?	N/A
	Road Slope (%)	1.3	N/A	Clear Space?	N/A
	Road X Slope (%)	2.1	N/A	Clear Space to XWalk (in)	N/A
N/A	Any Obstructions?	N/A	N/A	Storm Grate/Utility Hazard?	N/A
	Obstruction Type			Storm Grate/Utility Type	
		N/A			N/A
		Yes		Surface Condition? (G/P)	Good

Possible Solutions:

Remove & Replace Curb Ramp With Two New Directional Ramps or Equivalent.
