Access Compliance Report Public Rights-of-Way (Curb Ramps)

Intersection ID: N/A Main Street: CRESSWIND BV **Cross Street: TREESDALE LN** Location: W ADA ID: B08500C5A48C Ramp Type: BlendTrans1 Initial Pass/Fail: Fail **Overall Compliance: No Severity Score:** 1.25

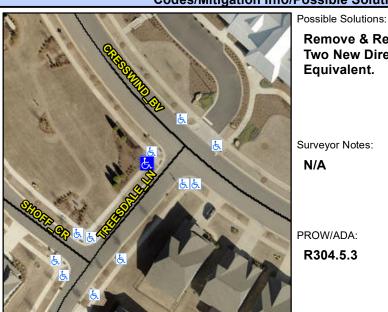
Field Measurements/Component Compliance						
	Compliance Description		Data	Compliance Description		Data
	N/A	Ramp Length (in)	106.0	Yes	BlendTrans Slope (%)	3.8
	Yes	Ramp Width (in)	60.0	No	BlendTrans XSlope (%)	2.5
	N/A	Flare Type LT	N/A	N/A	Flare Type RT	N/A
	N/A	Flare Slope LT (%)	N/A	N/A	Flare Slope RT (%)	N/A
	N/A	Flare Traversable LT?	No	N/A	Flare Traversable RT?	No
	N/A	Landing Length (in)	N/A	N/A	DWS Provided?	N/A
	N/A	Landing Width (in)	N/A	N/A	DWS Contrast?	N/A
	N/A	Landing Slope (%)	N/A	N/A	DWS Length (in)	N/A
	N/A	Landing X Slope (%)	N/A	N/A	DWS Full Width?	N/A
	N/A	Landing Curb? (Y/N)	N/A	N/A	DWS Offset (in)	N/A
	N/A	Shared Landing?	N/A			
	N/A	Gutter Ponding?	N/A	N/A	Gutter Slope (%)	N/A
	N/A	Gutter Lip Ht (in)	2.0	N/A	Gutter X Slope (%)	N/A
	N/A	Painted X Walk1?	No	N/A	Painted X Walk2?	N/A
		X Walk 1 Direction	To SE		X Walk 2 Direction	N/A
		X Walk 1 Width (in)	N/A		X Walk 2 Width (in)	N/A

X Walk 1 Slope (%)	3.5		X Walk 2 Slope (%)	N/A
		X Walk 1 X Slope (%)	2.4		X Walk 2 X Slope (%)	N/A
	N/A	Ramp inside XWalk1?	N/A	N/A	Ramp inside XWalk2?	N/A
		Road Slope (%)	2.4		Clear Space?	N/A
		Road X Slope (%)	3.5	N/A	Clear Space to XWalk (in)	N/A
	N/A	Any Obstructions?	N/A	N/A	Storm Grate/Utility Hazard?	N/A
		Obstruction Type		l	Storm Grate/Utility Type	
			N/A	l		N/A
				Yes	Surface Condition? (G/P)	Good

Remove & Replace Curb Ramp With Two New Directional Ramps or Equivalent.

R304.5.3
