## Access Compliance Report Public Rights-of-Way (Curb Ramps)

Intersection ID: 13408Main Street:COMMONWEALTH\_AVCross Street:THE\_PLAZALocation:WADA ID: B08A38DB1F1CRamp Type:PerpInitial Pass/Fail:FailOverall Compliance:NoSeverity Score:8.75

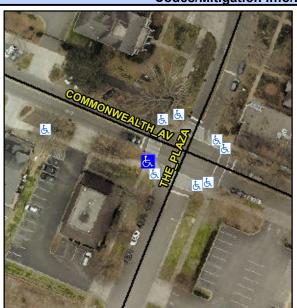
Not Found, R304.5.1

Field Measurements/Component Compliance							
Comp	oliance Description	Data	Comp	liance Description	Data		
N/A	Ramp Length (in)	60.0	Yes	Ramp Slope (%)	6.7		
No	Ramp Width (in)	47.0	Yes	Ramp XSlope (%)	1.0		
N/A	Flare Type LT	N/A	N/A	Flare Type RT	N/A		
N/A	Flare Slope LT (%)	N/A	N/A	Flare Slope RT (%)	N/A		
N/A	Flare Traversable LT?	N/A	N/A	Flare Traversable RT?	N/A		
N/A	Landing Length (in)	N/A	N/A	DWS Provided?	N/A		
N/A	Landing Width (in)	N/A	N/A	DWS Contrast?	N/A		
N/A	Landing Slope (%)	N/A	N/A	DWS Length (in)	N/A		
N/A	Landing X Slope (%)	N/A	N/A	DWS Full Width?	N/A		
N/A	Landing Curb? (Y/N)	N/A	N/A	DWS Offset (in)	N/A		
N/A	Shared Landing?	N/A					
N/A	Gutter Ponding?	N/A	N/A	Gutter Slope (%)	N/A		
N/A	Gutter Lip Ht (in)	N/A	N/A	Gutter X Slope (%)	N/A		
N/A	Painted X Walk1?	Yes	N/A	Painted X Walk2?	N/A		
	X Walk 1 Direction	To NE		X Walk 2 Direction	N/A		
N/A	X Walk 1 Width (in)	120.0	N/A	X Walk 2 Width (in)	N/A

X Walk 1 Slope (%)	1.9		X Walk 2 Slope (%)	N/A		
	X Walk 1 X Slope (%)	0.6		X Walk 2 X Slope (%)	N/A		
N/A	Ramp inside XWalk1?	Yes	N/A	Ramp inside XWalk2?	N/A		
	Road Slope (%)	N/A	N/A	Clear Space?	N/A		
	Road X Slope (%)	N/A	N/A	Clear Space to XWalk (in)	N/A		
N/A	Any Obstructions?	N/A	N/A	Storm Grate/Utility Hazard?	N/A		
	Obstruction Type			Storm Grate/Utility Type			
		N/A			N/A		
			Yes	Surface Condition? (G/P)	Good

Remove & Replace Entire Ramp.
