Access Compliance Report Public Rights-of-Way (Curb Ramps)

Intersection ID: 13035Main Street: W_CARSON_BVCross Street: WINNIFRED_STLocation: WADA ID: B0936D206751Ramp Type: PerpInitial Pass/Fail: FailOverall Compliance: NoSeverity Score: 12.5

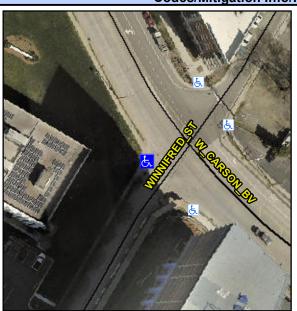
PROW/ADA:
R304.5.3

| Compliance Description | | Data | Comp | liance | Description | Data |
|---|---|---|---|---|---|---|
| Yes | Ramp Width (in) | 68.0 | No | Ramp XSlope (%) | | 5.3 |

Remove & Replace Entire Ramp.
