Access Compliance Report

Public Rights-of-Way

(Curb Ramps)

Intersection ID: 54465	Main Street: RUPELL_DR	Cross Street: COLLINGHAM_DR	Location: NW
ADA ID: B09371C85A7C	Ramp Type: BlendTrans1	Initial Pass/Fail: Fail	Overall Compliance: No
Codes/Mitigation Info/Possible Solution			Severity Score: 10
			Field Measurements/Component Compliance

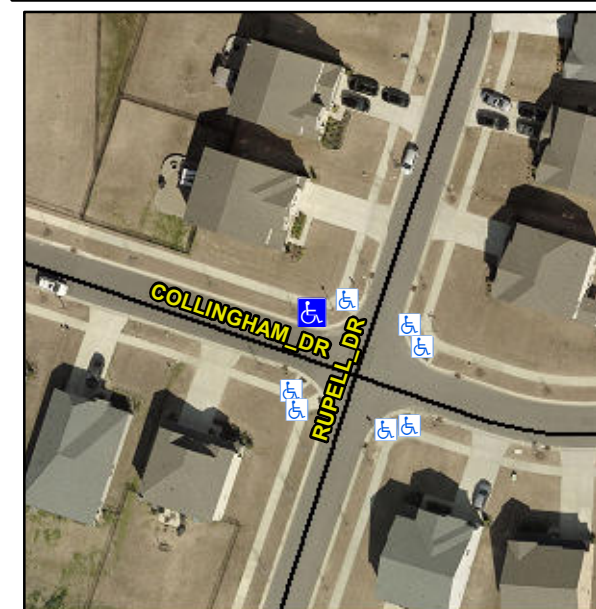
Not Found, R304.5.1, R304.5.3

Compliance	Description	Data	Compliance	Description	Data
N/A	Ramp Length (in)	99.0	Yes	BlendTrans Slope (%)	2.7
No	Ramp Width (in)	46.5	No	BlendTrans XSlope (%)	2.3
N/A	Flare Type LT	N/A	N/A	Flare Type RT	N/A
N/A	Flare Slope LT (%)	N/A	N/A	Flare Slope RT (%)	N/A
N/A	Flare Traversable LT?	N/A	N/A	Flare Traversable RT?	N/A
N/A	Landing Length (in)	N/A	N/A	DWS Provided?	N/A
N/A	Landing Width (in)	N/A	N/A	DWS Contrast?	N/A
N/A	Landing Slope (%)	N/A	N/A	DWS Length (in)	N/A
N/A	Landing X Slope (%)	N/A	N/A	DWS Full Width?	N/A
N/A	Landing Curb? (Y/N)	N/A	N/A	DWS Offset (in)	N/A
N/A	Shared Landing?	N/A			
N/A	Gutter Ponding?	N/A	N/A	Gutter Slope (%)	N/A
N/A	Gutter Lip Ht (in)	1.0	N/A	Gutter X Slope (%)	N/A
N/A	Painted X Walk1?	No	N/A	Painted X Walk2?	N/A
	X Walk 1 Direction	To SW		X Walk 2 Direction	N/A
	X Walk 1 Width (in)	N/A		X Walk 2 Width (in)	N/A
	X Walk 1 Slope (%)	2.5		X Walk 2 Slope (%)	N/A
	X Walk 1 X Slope (%)	0.5		X Walk 2 X Slope (%)	N/A

N/A	Ramp inside XWalk1?	N/A	N/A	Ramp inside XWalk2?	N/A
	Road Slope (%)	0.5		Clear Space?	N/A
	Road X Slope (%)	2.5	N/A	Clear Space to XWalk (in)	N/A
N/A	Any Obstructions?	N/A	N/A	Storm Grate/Utility Hazard?	N/A
	Obstruction Type			Storm Grate/Utility Type	
		N/A			N/A
			Yes	Surface Condition? (G/P)	Good
			No	Curb Slope (%)	14.6

Remove & Replace Curb Ramp With Two New Directional Ramps or Equivalent.
