Access Compliance Report

Public Rights-of-Way

(Curb Ramps)

| Intersection ID: 32299 | Main Street: HAZELVIEW_DR | Cross Street: OSWALD_LN | Location: NW |

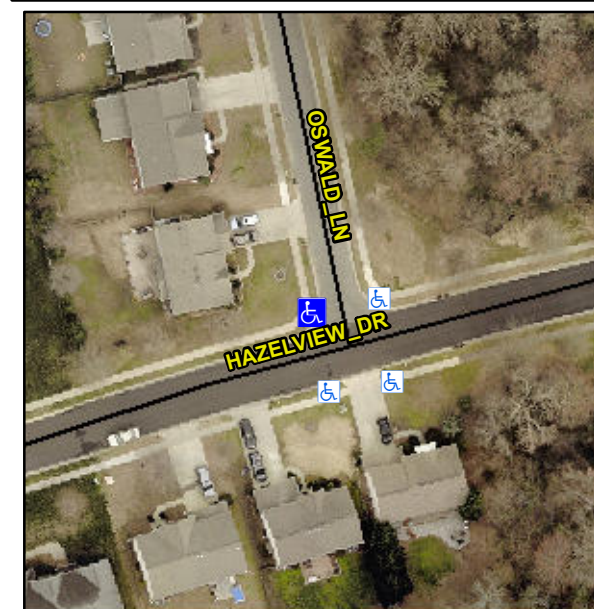
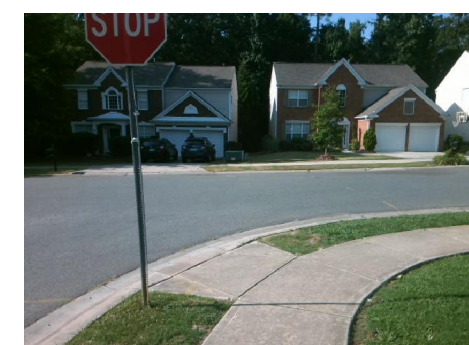
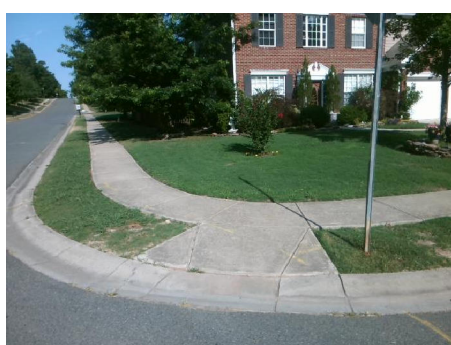
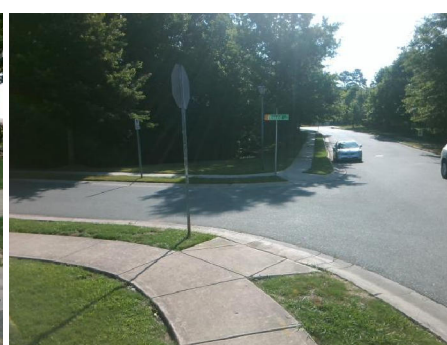
Not Found, R304.5.1, R304.2.2

| Compliance | Description | Data | Compliance | Description | Data |
|---|---|---|---|---|---|
| N/A | Ramp Length (in) | 95.5 | No | Ramp Slope (%) | 12.6 |
| No | Ramp Width (in) | 37.0 | Yes | Ramp XSlope (%) | 2.0 |

Remove & Replace Curb Ramp With Two New Directional Ramps or Equivalent.
