# Access Compliance Report

## Public Rights-of-Way

### (Curb Ramps)

Intersection ID: 27501	Main Street: BRUSH_HOLLOW_RD	Cross Street: BASKING_RIDGE_CT	Location: E
ADA ID: B09DC96F22E7	Ramp Type: Perp	Initial Pass/Fail: Fail	Overall Compliance: No
		Severity Score: 8.75

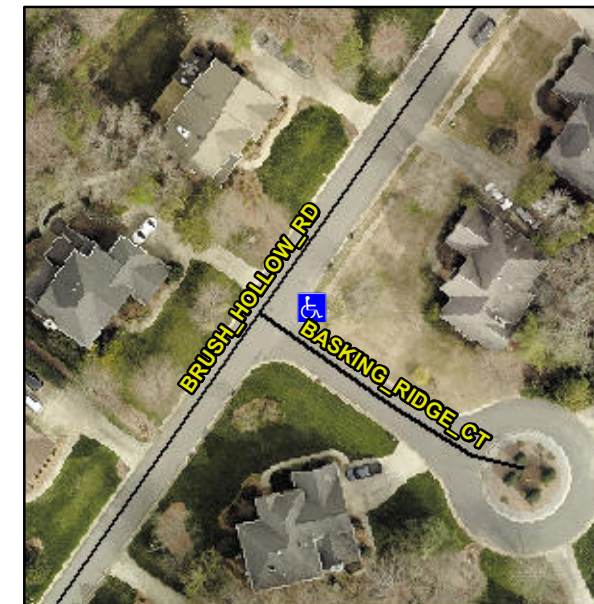
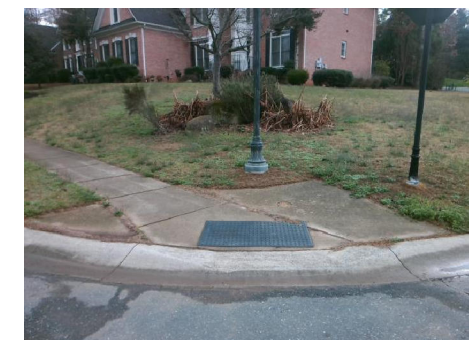
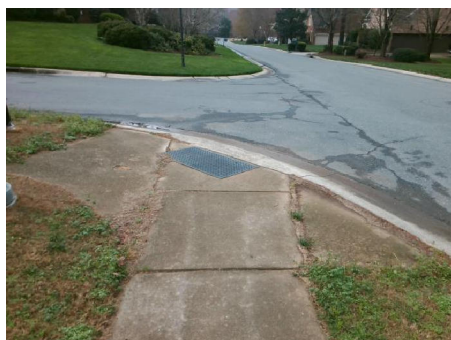
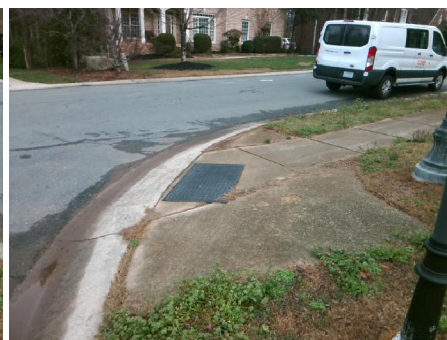
**Not Found, R304.5.1**

Compliance	Description	Data	Compliance	Description	Data
N/A	Ramp Length (in)	46.0	Yes	Ramp Slope (%)	7.8
No	Ramp Width (in)	46.0	Yes	Ramp XSlope (%)	0.2
N/A	Flare Type LT	N/A	N/A	Flare Type RT	N/A
N/A	Flare Slope LT (%)	N/A	N/A	Flare Slope RT (%)	N/A
N/A	Flare Traversable LT?	N/A	N/A	Flare Traversable RT?	N/A
N/A	Landing Length (in)	N/A	N/A	DWS Provided?	N/A
N/A	Landing Width (in)	N/A	N/A	DWS Contrast?	N/A
N/A	Landing Slope (%)	N/A	N/A	DWS Length (in)	N/A
N/A	Landing X Slope (%)	N/A	N/A	DWS Full Width?	N/A
N/A	Landing Curb? (Y/N)	N/A	N/A	DWS Offset (in)	N/A
N/A	Shared Landing?	N/A			
N/A	Gutter Ponding?	N/A	N/A	Gutter Slope (%)	N/A
N/A	Gutter Lip Ht (in)	N/A	N/A	Gutter X Slope (%)	N/A
N/A	Painted X Walk1?	No	N/A	Painted X Walk2?	N/A
	X Walk 1 Direction	To SW		X Walk 2 Direction	N/A
N/A	X Walk 1 Width (in)	N/A	N/A	X Walk 2 Width (in)	N/A
	X Walk 1 Slope (%)	0.7		X Walk 2 Slope (%)	N/A
	X Walk 1 X Slope (%)	0.3		X Walk 2 X Slope (%)	N/A

N/A	Ramp inside XWalk1?	N/A	N/A	Ramp inside XWalk2?	N/A
	Road Slope (%)	N/A	N/A	Clear Space?	N/A
	Road X Slope (%)	N/A	N/A	Clear Space to XWalk (in)	N/A
N/A	Any Obstructions?	N/A	N/A	Storm Grate/Utility Hazard?	N/A
	Obstruction Type			Storm Grate/Utility Type	
		N/A			N/A
			Yes	Surface Condition? (G/P)	Good

**Remove & Replace Entire Ramp.**

Total Cost: \$ 1850.00
