# Access Compliance Report

## Public Rights-of-Way

### (Curb Ramps)

| Intersection ID: 14692 | Main Street: BAXTER_ST | Cross Street: QUEENS_RD | Location: | S |

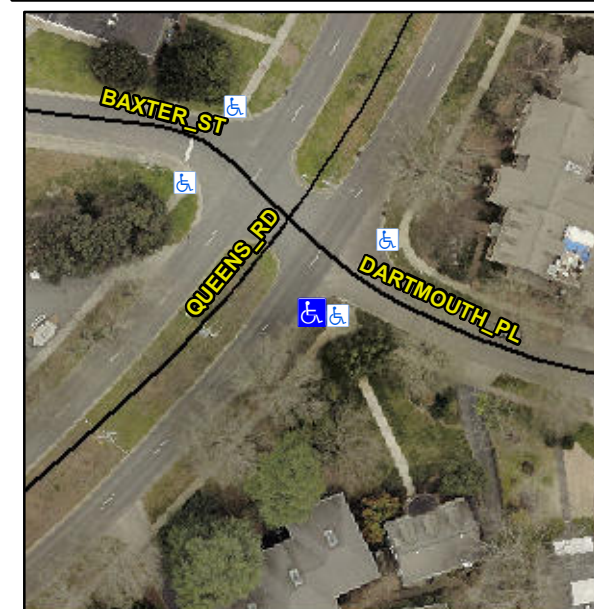
| ADA ID: B09E7D92E7F5 | Ramp Type: Perp | Initial Pass/Fail: Fail | Overall Compliance: No | Severity Score: 12.5 |

**Not Found, R304.5.3**

| Compliance | Description | Data | Compliance | Description | Data |
|---|---|---|---|---|---|
| Yes | Ramp Width (in) | 49.0 | No | Ramp XSlope (%) | 5.4 |

**Remove & Replace Entire Ramp.**

Total Cost: \$ 1850.00
