Access Compliance Report

Public Rights-of-Way

(Curb Ramps)

Intersection ID: 27727	Main Street: KINGSTON_FOREST_DR	Cross Street: LEINSTER_DR	Location: S
ADA ID: B0AC1DE27676	Ramp Type: PerpDiag	Initial Pass/Fail: Fail	Overall Compliance: No
Severity Score: 31.25			
Codes/Mitigation Info/Possible Solution		Field Measurements/Component Compliance

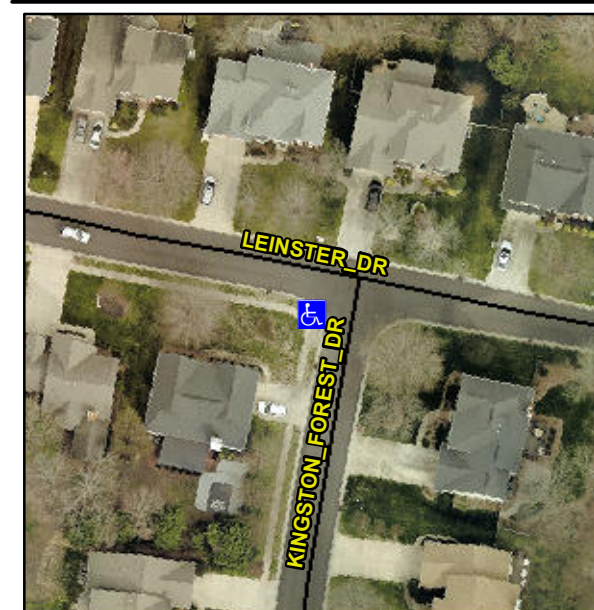
Compliance	Description	Data	Compliance	Description	Data
N/A	Ramp Length (in)	53.0	No	Ramp Slope (%)	11.9
No	Ramp Width (in)	34.0	No	Ramp XSlope (%)	3.0
N/A	Flare Type LT	N/A	N/A	Flare Type RT	N/A
N/A	Flare Slope LT (%)	N/A	N/A	Flare Slope RT (%)	N/A
N/A	Flare Traversable LT?	N/A	N/A	Flare Traversable RT?	N/A
N/A	Landing Length (in)	N/A	N/A	DWS Provided?	N/A
N/A	Landing Width (in)	N/A	N/A	DWS Contrast?	N/A
N/A	Landing Slope (%)	N/A	N/A	DWS Length (in)	N/A
N/A	Landing X Slope (%)	N/A	N/A	DWS Full Width?	N/A
N/A	Landing Curb? (Y/N)	N/A	N/A	DWS Offset (in)	N/A
N/A	Shared Landing?	N/A			
N/A	Gutter Ponding?	N/A	N/A	Gutter Slope (%)	N/A
N/A	Gutter Lip Ht (in)	N/A	N/A	Gutter X Slope (%)	N/A
N/A	Painted X Walk1?	No	N/A	Painted X Walk2?	No
	X Walk 1 Direction	To SE		X Walk 2 Direction	To N
N/A	X Walk 1 Width (in)	N/A	N/A	X Walk 2 Width (in)	N/A
	X Walk 1 Slope (%)	0.1		X Walk 2 Slope (%)	3.0
	X Walk 1 X Slope (%)	0.3		X Walk 2 X Slope (%)	2.9

N/A	Ramp inside XWalk1?	N/A	N/A	Ramp inside XWalk2?	N/A
	Road Slope (%)	2.7	N/A	Clear Space?	N/A
	Road X Slope (%)	0.9	N/A	Clear Space to XWalk (in)	N/A
N/A	Any Obstructions?	N/A	N/A	Storm Grate/Utility Hazard?	N/A
	Obstruction Type			Storm Grate/Utility Type	
		N/A			N/A
			Yes	Surface Condition? (G/P)	Good

Possible Solutions:

Remove & Replace Curb Ramp With Two New Directional Ramps or Equivalent.

R304.5.1, R304.2.2, R304.5.3
