Access Compliance Report

Public Rights-of-Way

(Curb Ramps)

Intersection ID: 29776	Main Street: GUINEVERE_DR	Cross Street: KING_ARTHUR_DR	Location: NE
ADA ID: B0AD1D91DD1F	Ramp Type: BlendTrans1	Initial Pass/Fail: Fail	Overall Compliance: No
Severity Score: 8.75			
Codes/Mitigation Info/Possible Solution		Field Measurements/Component Compliance

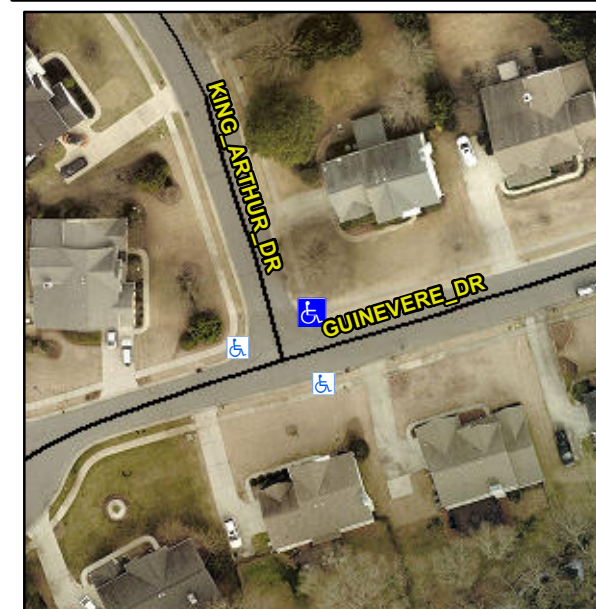
Not Found, R304.5.1

Compliance	Description	Data	Compliance	Description	Data
N/A	Ramp Length (in)	33.0	Yes	BlendTrans Slope (%)	4.6
No	Ramp Width (in)	46.0	Yes	BlendTrans XSlope (%)	0.9
N/A	Flare Type LT	N/A	N/A	Flare Type RT	N/A
N/A	Flare Slope LT (%)	N/A	N/A	Flare Slope RT (%)	N/A
N/A	Flare Traversable LT?	N/A	N/A	Flare Traversable RT?	N/A
N/A	Landing Length (in)	N/A	N/A	DWS Provided?	N/A
N/A	Landing Width (in)	N/A	N/A	DWS Contrast?	N/A
N/A	Landing Slope (%)	N/A	N/A	DWS Length (in)	N/A
N/A	Landing X Slope (%)	N/A	N/A	DWS Full Width?	N/A
N/A	Landing Curb? (Y/N)	N/A	N/A	DWS Offset (in)	N/A
N/A	Shared Landing?	N/A			
N/A	Gutter Ponding?	N/A	N/A	Gutter Slope (%)	N/A
N/A	Gutter Lip Ht (in)	N/A	N/A	Gutter X Slope (%)	N/A
N/A	Painted X Walk1?	No	N/A	Painted X Walk2?	No
	X Walk 1 Direction	To SW		X Walk 2 Direction	To S
	X Walk 1 Width (in)	N/A		X Walk 2 Width (in)	N/A
	X Walk 1 Slope (%)	3.0		X Walk 2 Slope (%)	0.5
	X Walk 1 X Slope (%)	0.7		X Walk 2 X Slope (%)	0.8

N/A	Ramp inside XWalk1?	N/A	N/A	Ramp inside XWalk2?	N/A
	Road Slope (%)	0.5		Clear Space?	N/A
	Road X Slope (%)	0.5	N/A	Clear Space to XWalk (in)	N/A
N/A	Any Obstructions?	N/A	N/A	Storm Grate/Utility Hazard?	N/A
	Obstruction Type			Storm Grate/Utility Type	
		N/A			N/A
			Yes	Surface Condition? (G/P)	Good
			No	Curb Slope (%)	10.3

Remove & Replace Curb Ramp With Two New Directional Ramps or Equivalent.
