# Access Compliance Report

## Public Rights-of-Way

### (Curb Ramps)

| Intersection ID: 50633 | Main Street: BLUE_BLOSSOM_RD | Cross Street: CORAL_ROSE_RD | Location: SW |

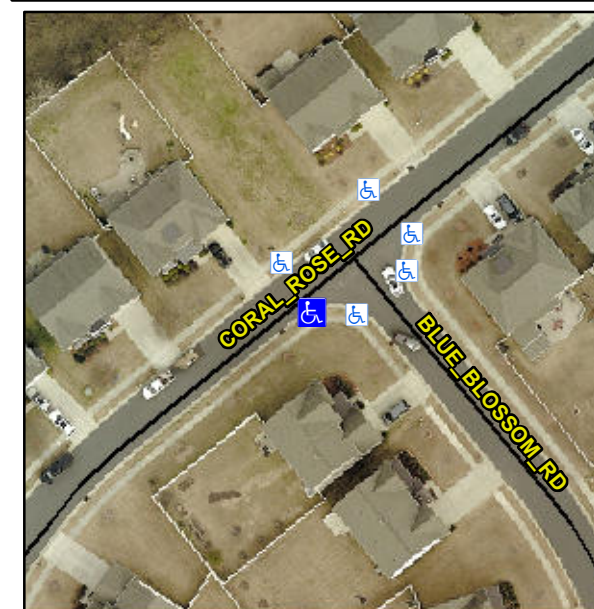
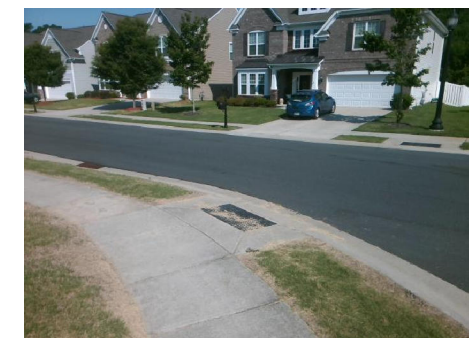
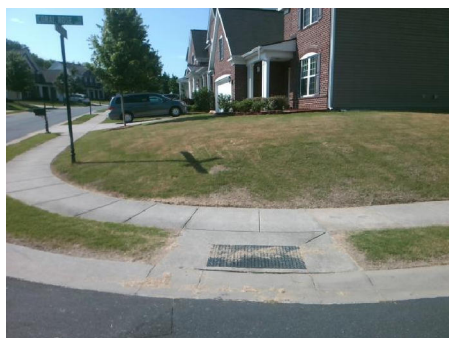
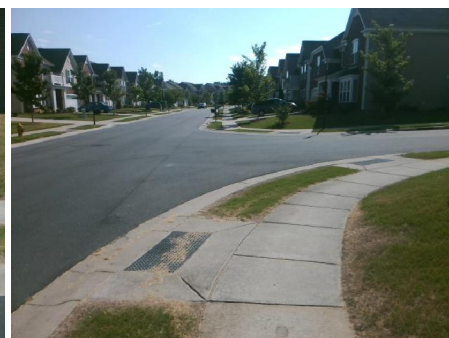
| ADA ID: B0AD80F8B77D | Ramp Type: Perp | Initial Pass/Fail: Pass | Overall Compliance: No |

**Not Found, R304.2.2-Perp, R304.3.2-  
Para, R305.2, R304.5.3**

| Compliance | Description | Data | Compliance | Description | Data |
|---|---|---|---|---|---|
| No | Landing Slope (%) | 4.1 | Yes | DWS Length (in) | 25.5 |
| N/A | Landing Curb? (Y/N) | No | No | DWS Offset (in) | 3.5 |
| Yes | Gutter Lip Ht (in) | 0.0 | No | Gutter X Slope (%) | 2.3 |

Possible Solutions:

**Remove & Replace Entire Ramp.  
Remove & Replace Gutter.**

Total Cost: \$ 2600.00
